Denver Urban Renewal Authority ASARCO Site Blight Study

October 2008

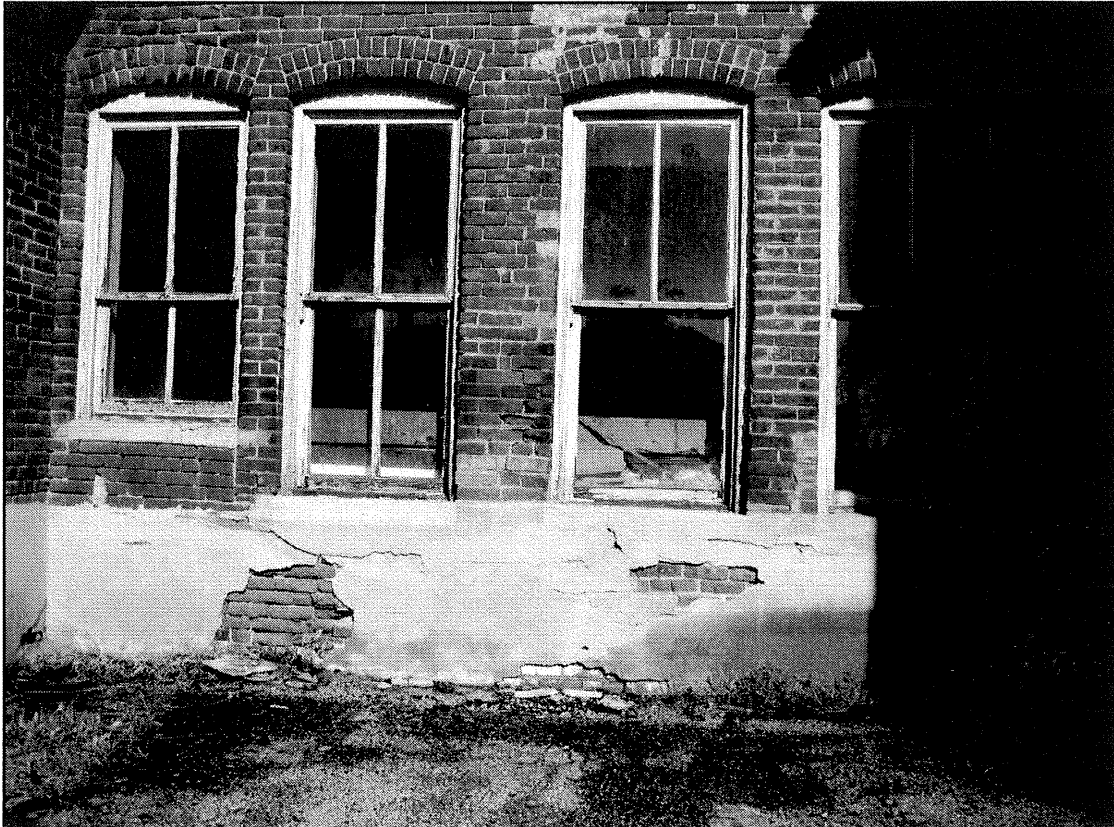
Figure 2-1: Deteriorated Wall

A deteriorated wall, one of many physical conditions leading to blight, is seen here on one of the 50-plus buildings on the ASARCO Site.

The majority of the structures within the ASARCO Study Area show signs of deterioration, and many display signs of poor maintenance, deterioration, and/or damage. These deteriorated building components include damaged or broken windows and doors, visible weathering of exterior finishes, damage and deterioration of loading dock areas, crumbling and cracked building fascia, visual weathering and deterioration of parapets and soffits, damage and deterioration of fences and gates, and deterioration of ancillary structures. Of the six factors evaluated, deterioration of structures was the most prevalent.
