3330 Brighton Boulevard Conditions Study

February 2015

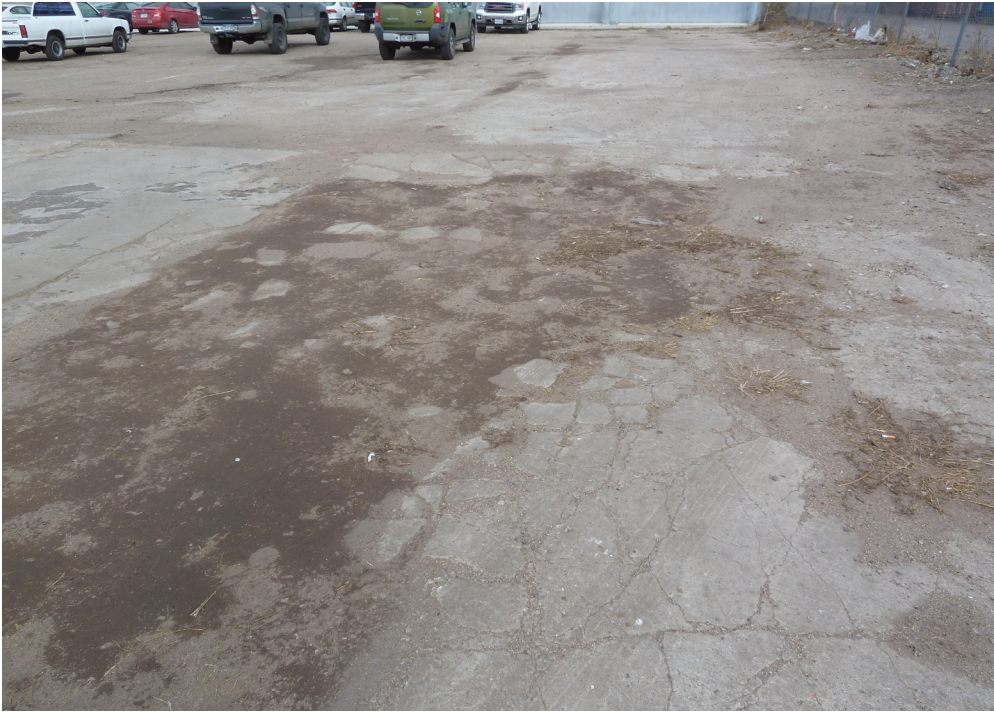
Broken, deteriorated, and uneven pavement is common throughout the property; in some areas it is lacking entirely even though the property is currently used as a commercial parking lot and experiences the associated pedestrian activity. Debris and some illegal dumping was also apparent in various places throughout the property.

Deteriorated pavement

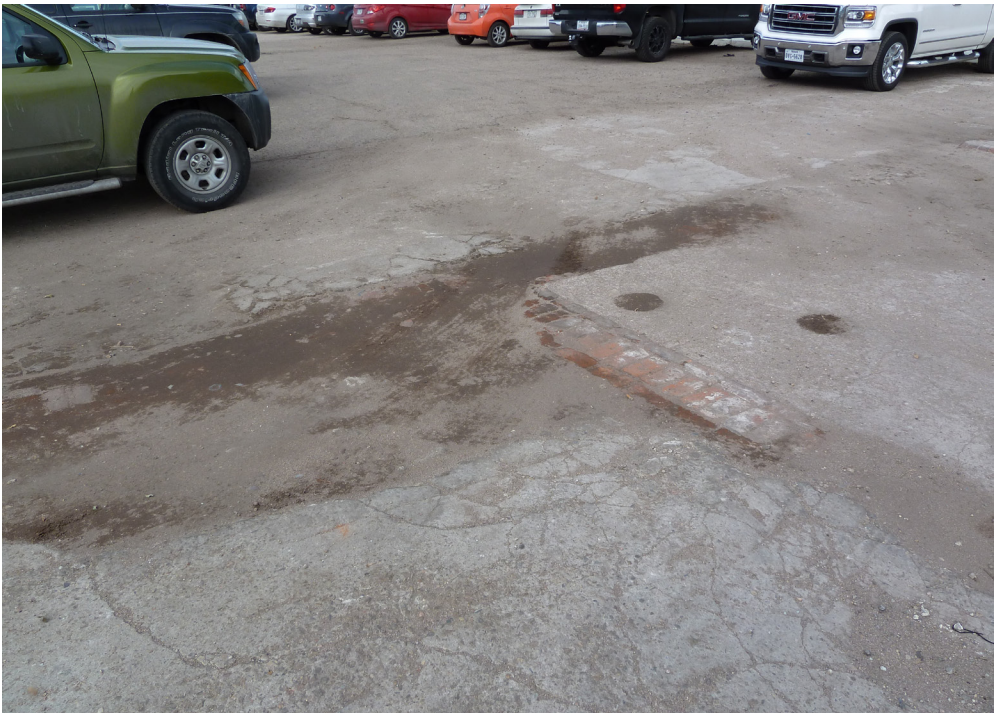
The remains of the foundation of a former structure on the property are evident, as are buried tracks from a former railroad spur on the property. This suggests that the site has not been fully excavated during the demolition of the former structure, and will need to be as part of the redevelopment of the property. The amount of additional excavation work needed is unknown, but could be significant.

Potholes and remnants of building foundations and railroad tracks still exist in places on the uneven parking surface

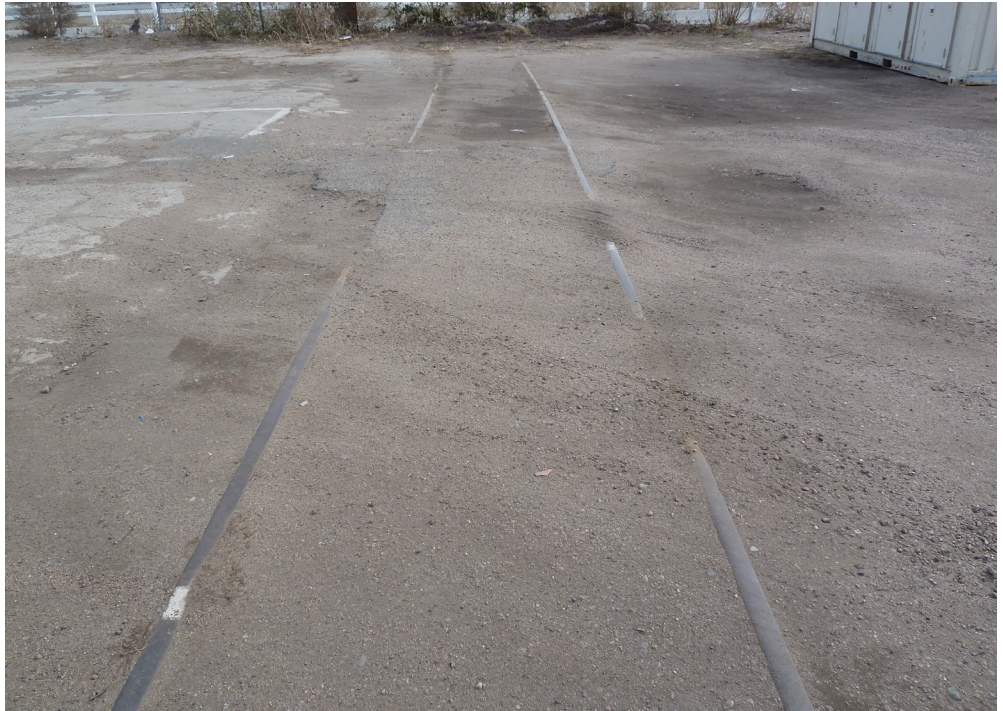
Remnants of rail tracks

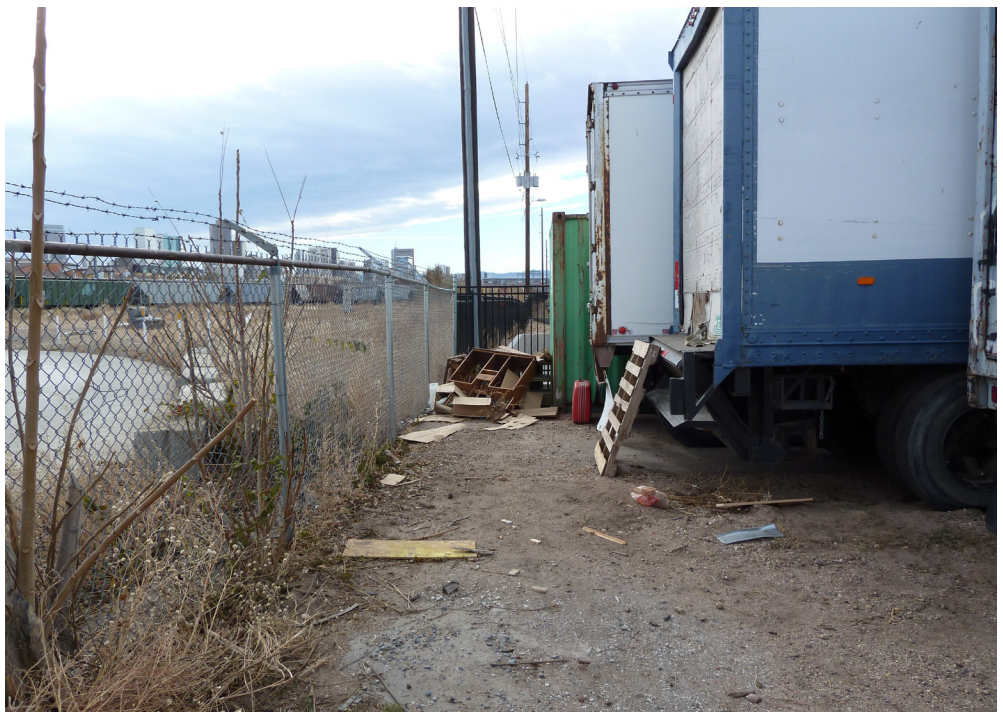
A portion of the property is still used for storage and has collected debris

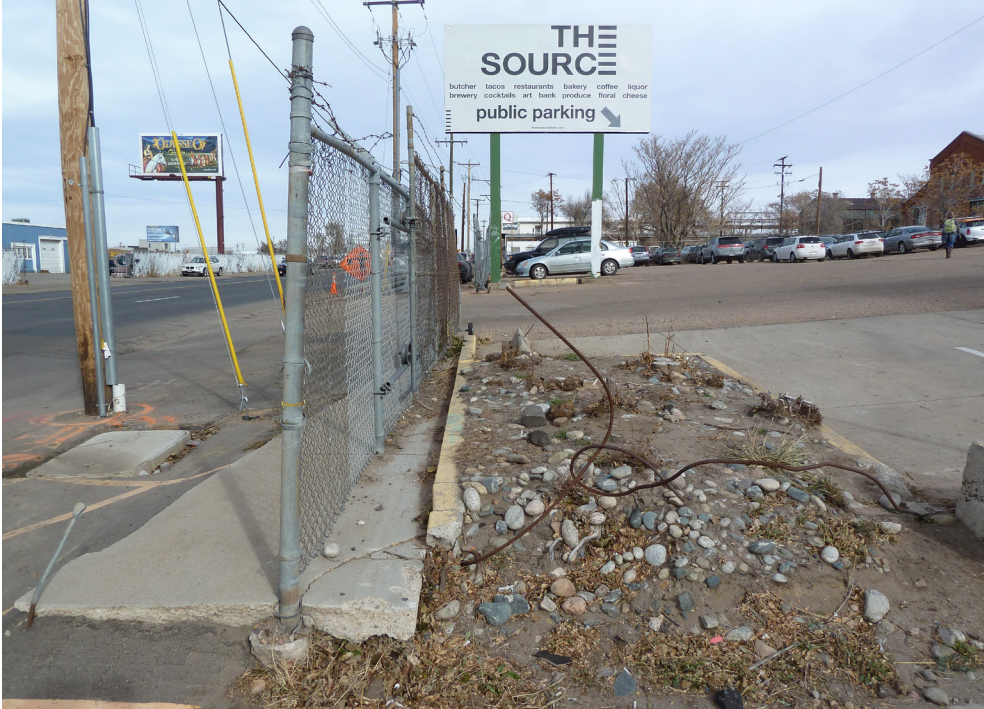
Twisted rebar at the entrance contribute to a sense of a general lack of maintenance

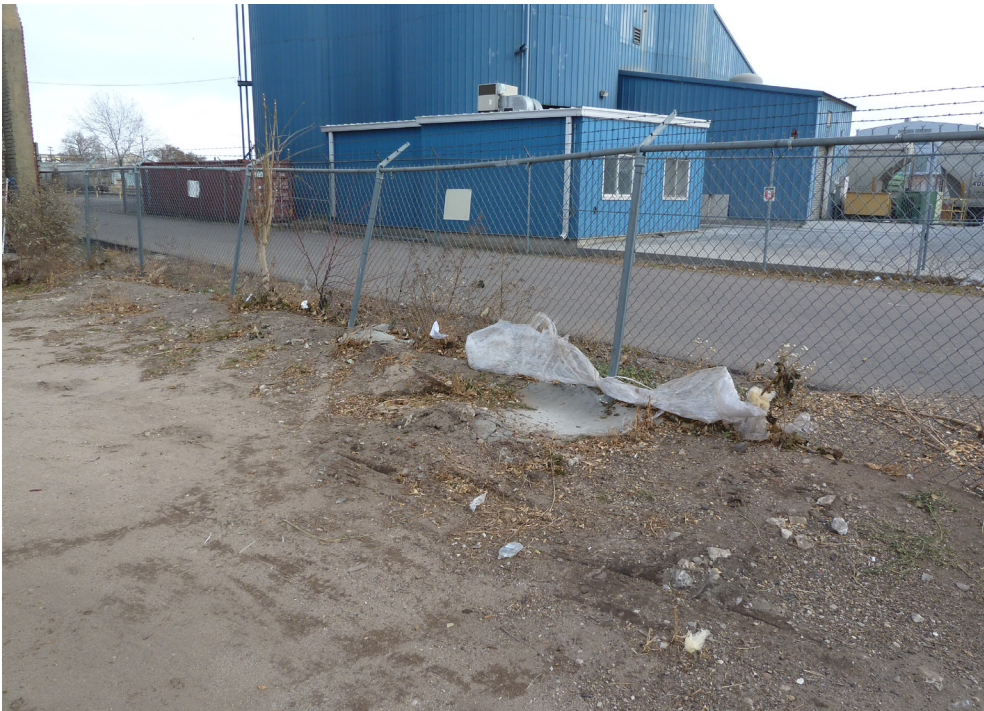
The fence at the rear of the property is dilapidated and collects trash and vegetation

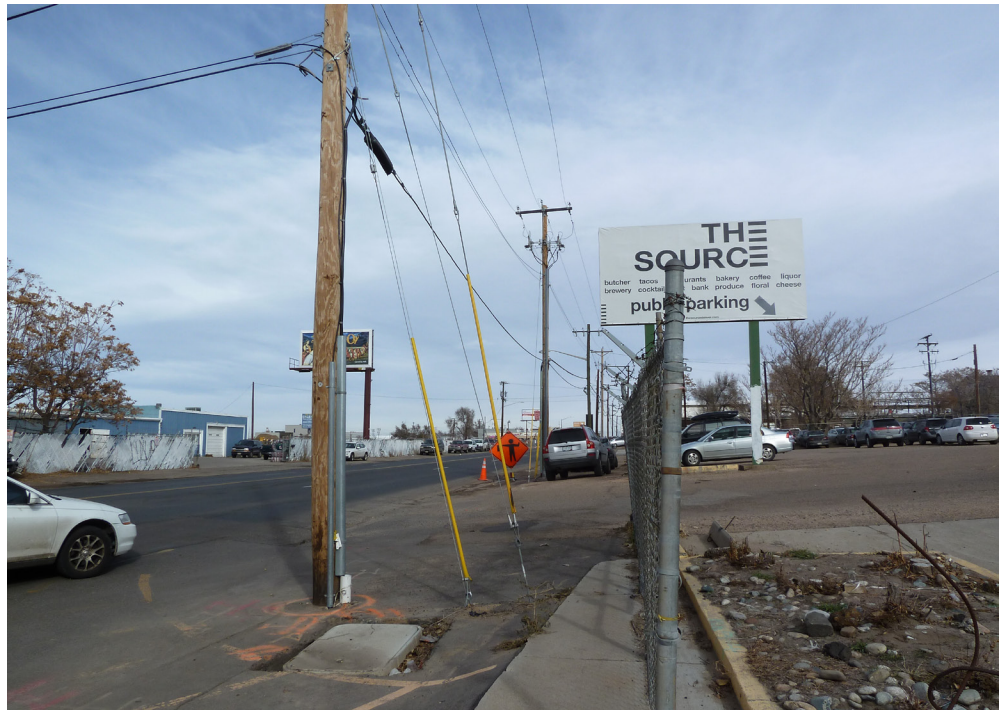
There is, however, a significant lack of public improvements throughout the property and the adjacent Brighton Boulevard right-of-way. The most notable examples are a lack of curb and gutter as well as sidewalks along the northwest boundary of the property, along Brighton Boulevard. Any pedestrians on this increasingly mixed-use corridor must navigate uneven pavement, standing water, parked cars, utility poles, and other obstacles if they wish maintain a safe distance from automobile traffic.

The Brighton Boulevard right of way provides no amenities adjacent to the property as currently configured

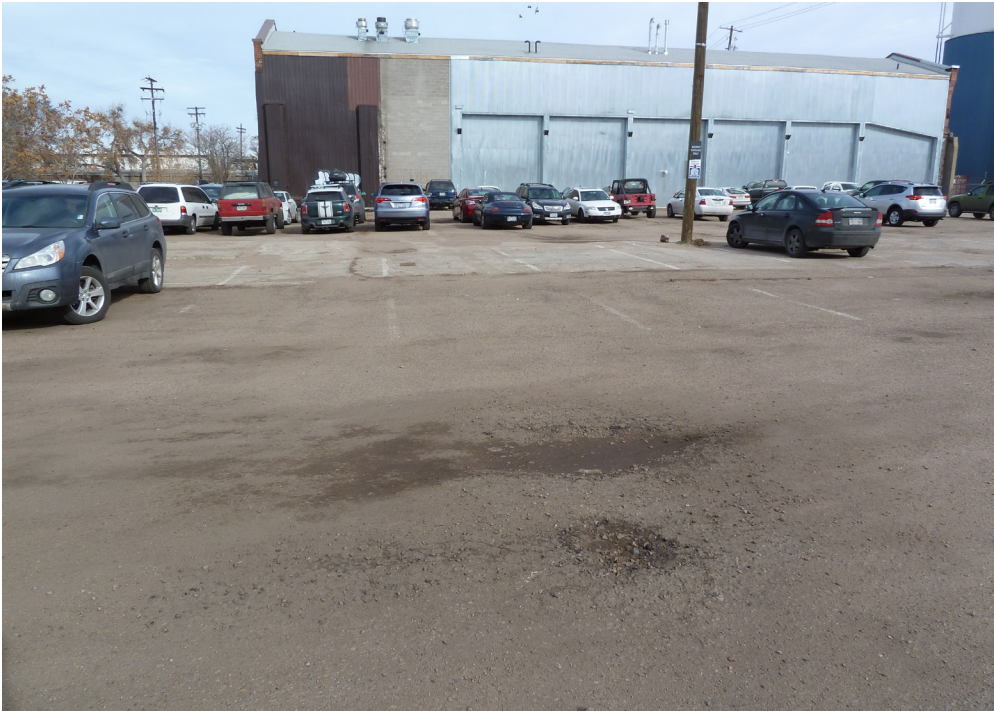
In its current state, if the lot was not used for parking, which even now is an informal use given the unpaved or poorly paved nature of the property, it would be completely vacant except for a few remaining storage crates.

The 3330 Brighton Boulevard property remains underutilized
