# Emily Griffith Technical College Conditions Study

July 2017

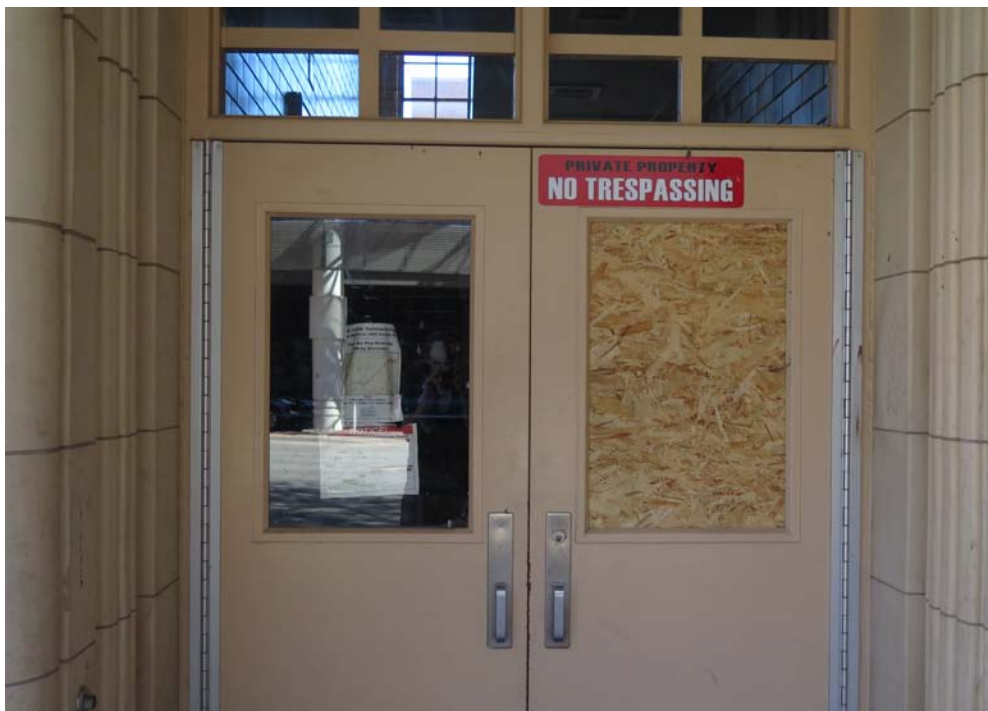
At the time of the field survey performed in September 2016, structures in the Study Area were found to be in fair condition; most issues found were related to broken windows in the school buildings. These broken windows were fairly widespread, but all had been boarded, suggesting that ongoing maintenance is still occurring despite the vacancy of the campus.

Overall, the broken windows in the Study Area contributed to a sense of neglect, but the ongoing boarding of any broken windows has prevented the issue from becoming a safety issue due to broken glass and vagrants trespassing on the property. Nevertheless, as time progresses, the frequency of broken windows continues to increase, and the campus buildings become increasingly dilapidated. The former campus has been closed for about a year, and nearly a dozen broken windows now exist.

*Boarded window at north entrance to Emily Griffith property*

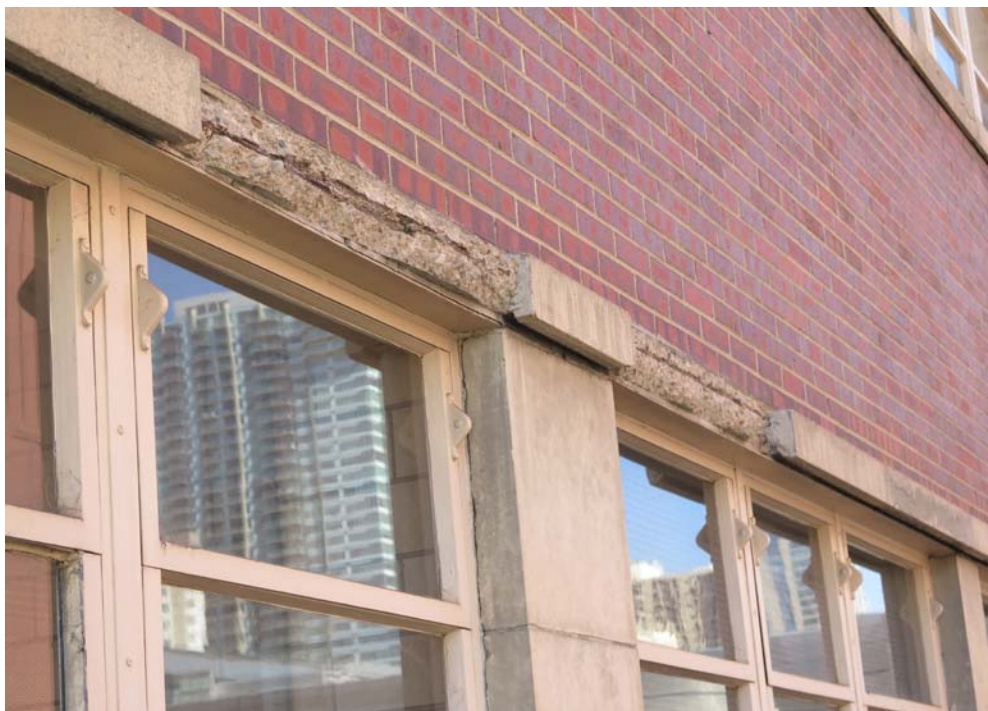
An additional area of concern was noted with the concrete window lintels, which were severely crumbled in many locations, creating small piles of rubble on the ground underneath them.

*Deteriorated exterior elements above windows at Emily Griffith property*

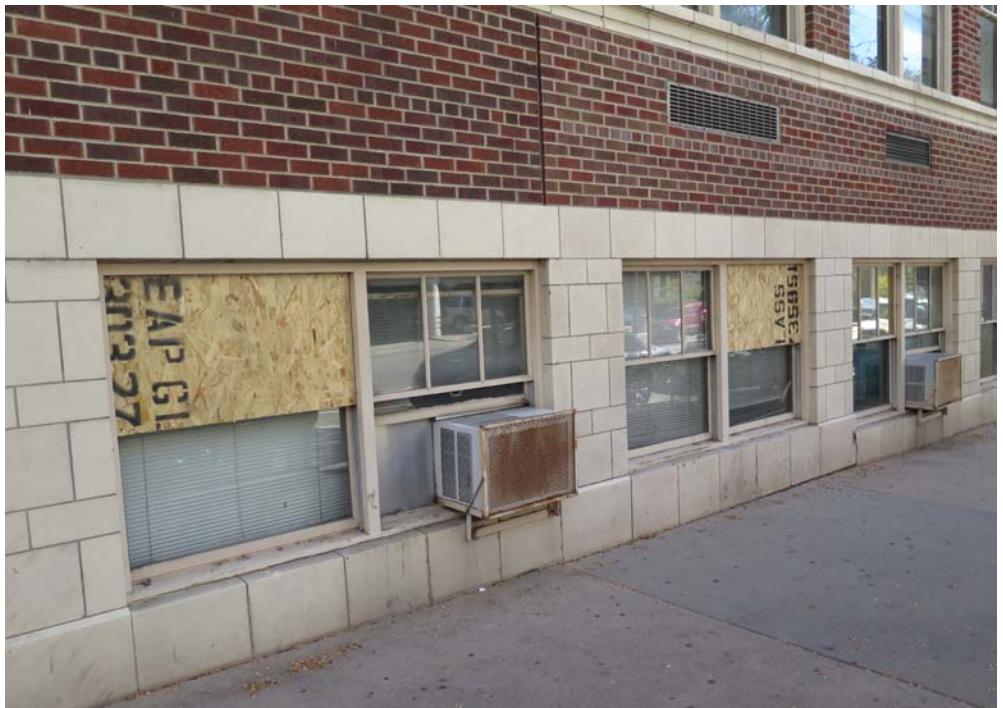
*Broken windows at Emily Griffith property*

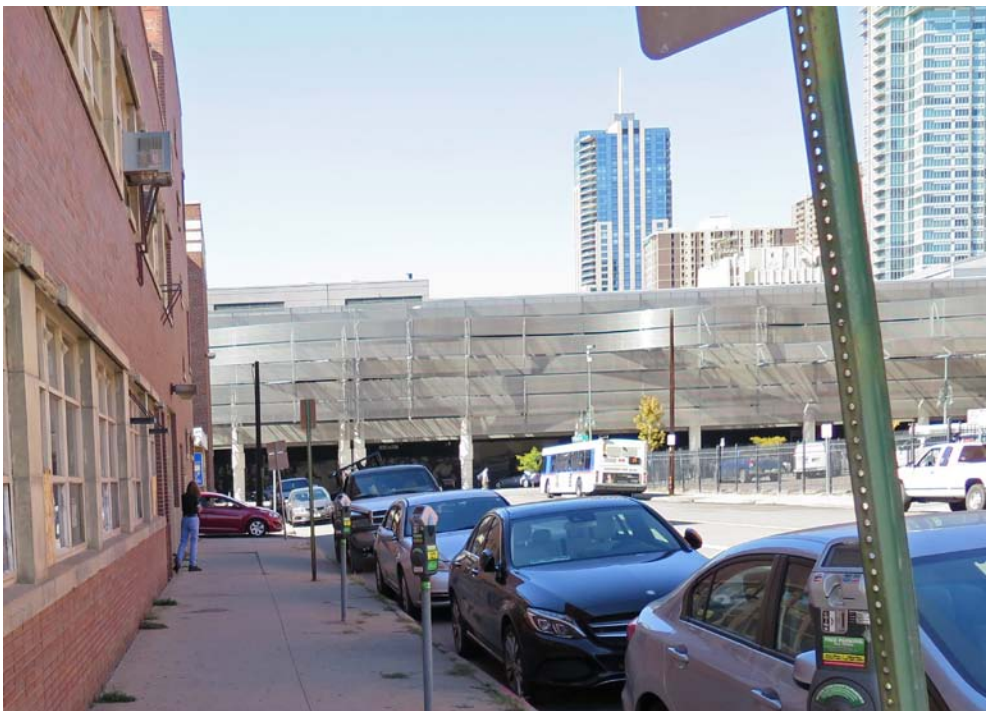
There is relatively poor circulation in the vicinity of the Study Area relative to the rest of the Central Business District and Civic Center area. The Study Area is immediately adjacent to the Colorado Convention Center, which is a sprawling structure occupying more than six full city blocks. The sheer size of the convention center breaks the continuity of the street grid in the area with the exception of Stout Street, which passes underneath the convention center but does not serve any of the property in the Study Area. The Convention Center is one of the largest “superblocks” in the downtown area (a block larger than a single City block), but it is also important to note the presence of the Lindsey-Flanigan Courthouse and Van Cise-Simonet Detention Center to the south, as well as the Denver Center for Performing Arts and the Auraria Campus in the vicinity to the west; all three properties also break the continuity of the street grid, creating dead ends and a lack of redundancy that funnels traffic onto certain streets and creates longer walking distances for pedestrians.

*The convention center, the size of six city blocks, breaks up the street grid and forms a barrier along the northwestern edge of the Study Area*

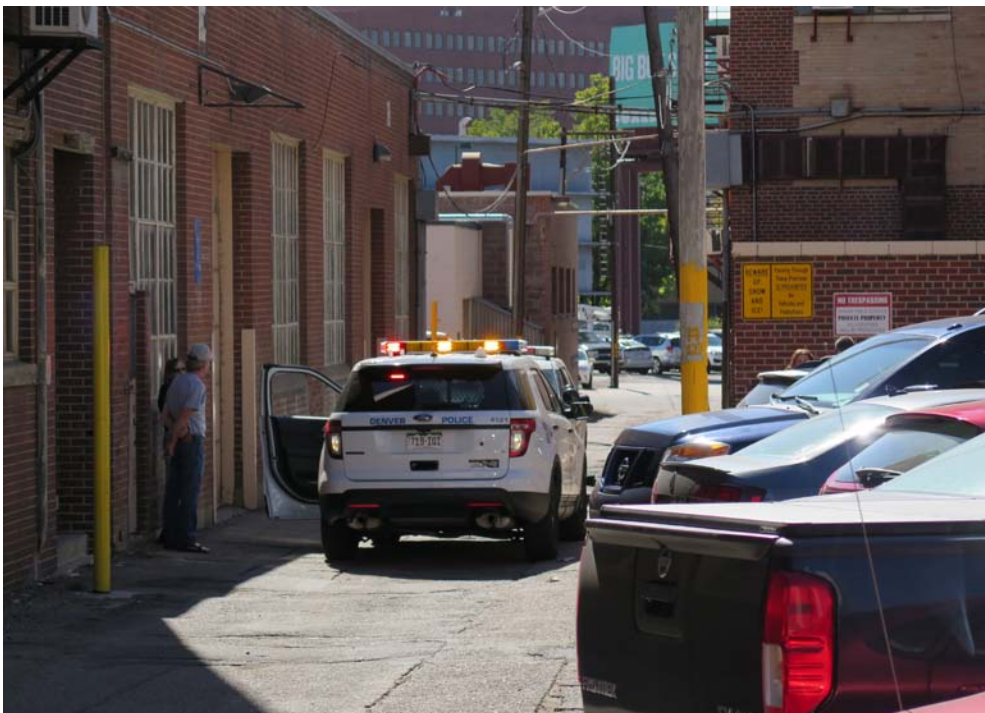
Records from the Denver Police Department show that over the past five years (January 1, 2012 - July 12, 2017), there were 115 reported crimes in the Study Area and in the surrounding rights-of way, not including minor traffic incidents. Emergency responses are more frequent still; one was observed during the field survey but never recorded as a reported crime.

*Emergency responses are relatively common in the Study Area*

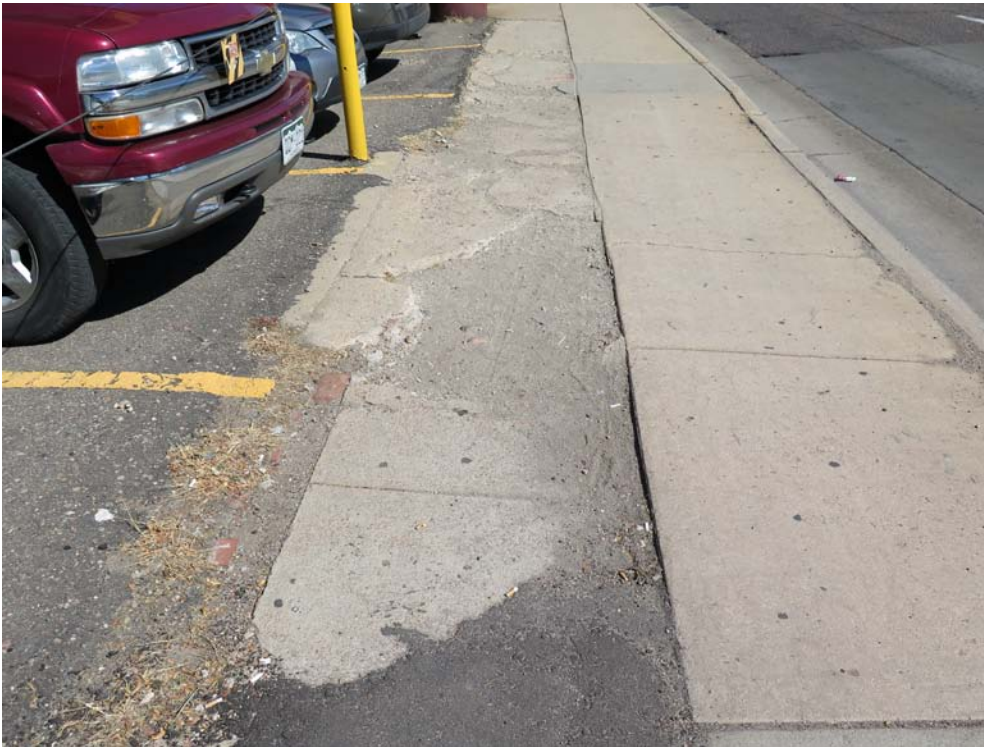
There was one section of sidewalk along the northern edge of Colfax Avenue near the Study Area that was noted to be in need of repair, but otherwise sidewalks were in good condition.

*A sidewalk in degraded condition along Colfax*

Sidewalk repair is needed along Colfax in the vicinity of the Study Area, but this is a minor issue overall.

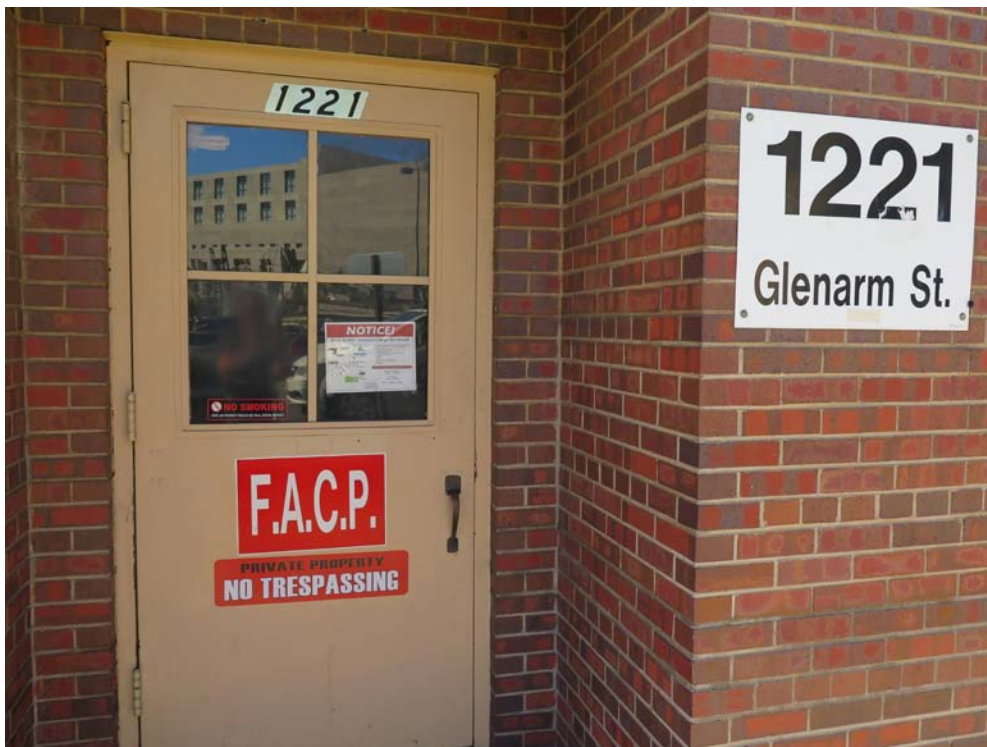
Additionally, relative to the rest of the Central Business District, the Study Area is substantially underutilized. The Area's most prominent and defining feature is the former campus of the Emily Griffith Technical College, which is a full city block that lies vacant. In the year since the closing of the campus, the old building has steadily gained boarded windows as broken ones are patched to prevent issues with vagrancy, but not replaced.

*All entrances to any school buildings in the Study Area are marked with notices of closure and signs forbidding trespassing*
