# Structure Review Report

401 Madison Street  
Denver, CO 80206

Thursday  
October 27, 2022

Subject: Barton Consulting Services, LLC Project #22-124  
**Structural Report**  
401 Madison Street  
City & County of Denver, Colorado

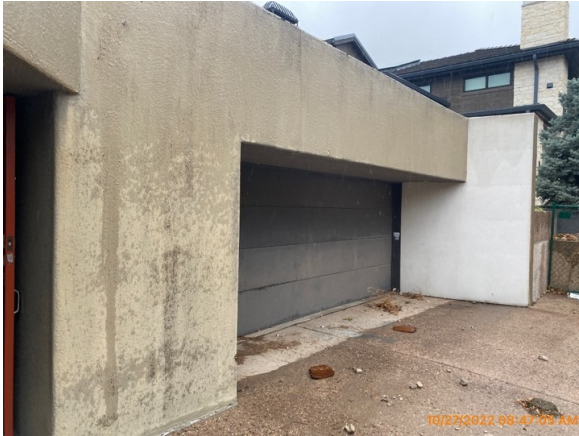
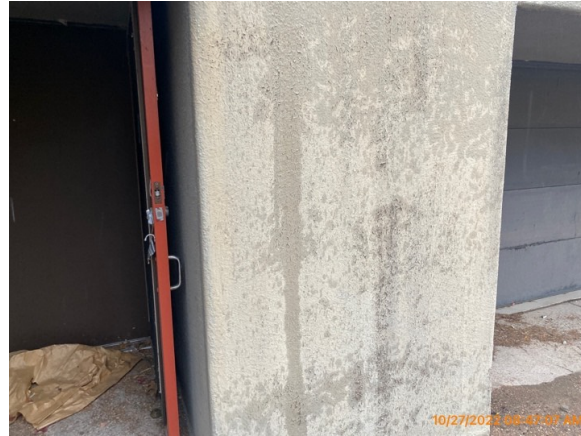
**DEF 6:** Siding condition was overall in poor condition. Top coat of EIFS stucco was visible deteriorated at multiple locations with damaged, cracks and signs of staining from moisture intrusion. This can allow for moisture intrusion.

Deteriorated top coat

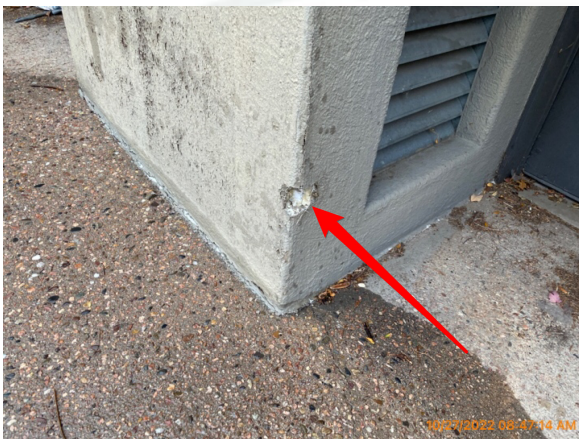
Damage at corner

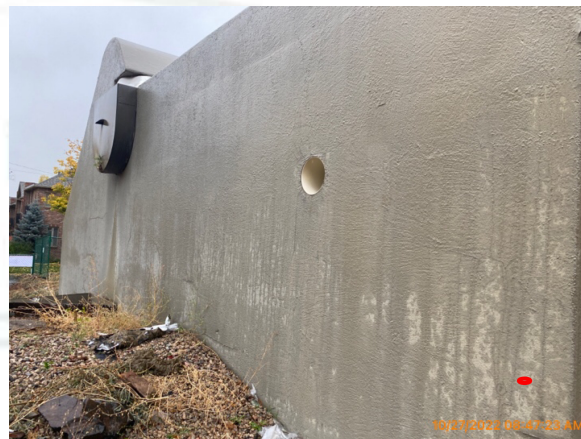
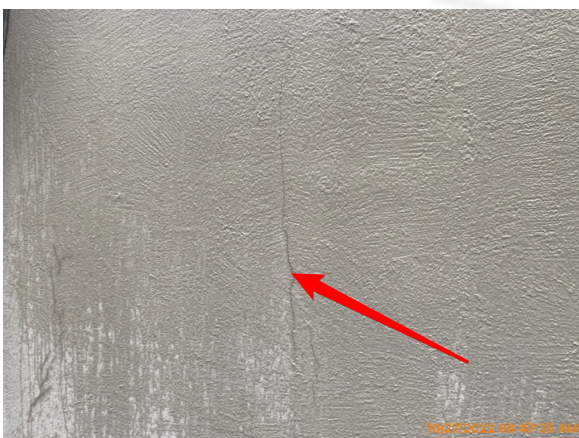
Cracks visible in stucco

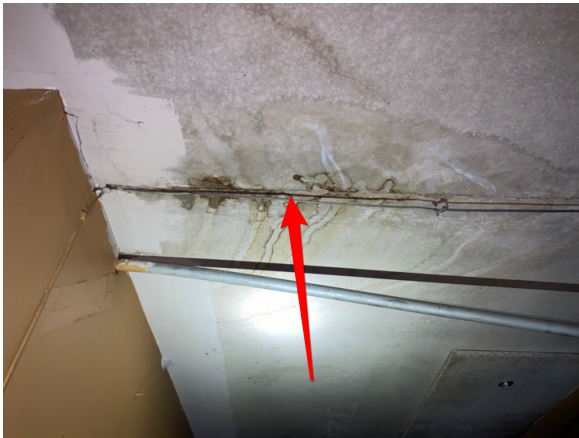
**MAR 7:** Garage consisted of concrete slab with concrete ceiling. Ceiling structure had cracks visible with signs of moisture intrusion.

Visible leak

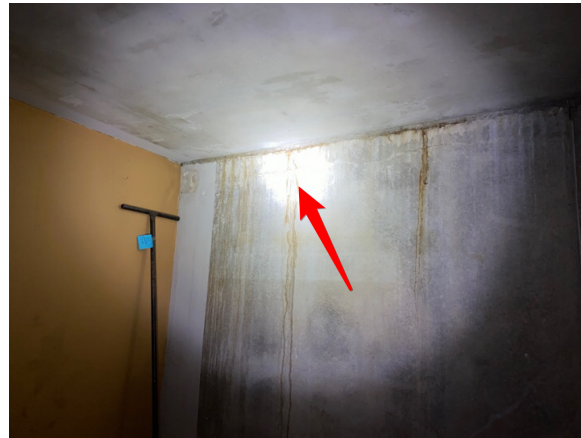
Visible leaking on wall

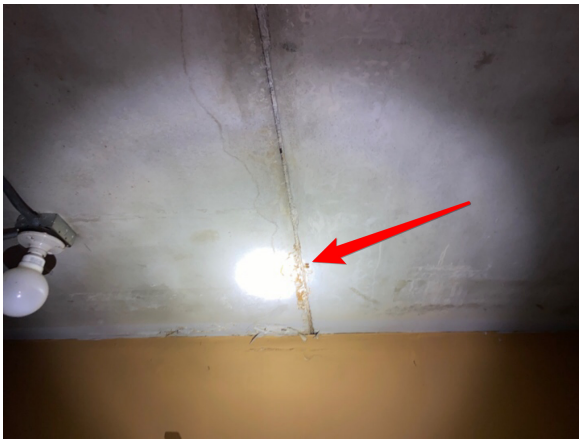
Visible leaking on ceiling

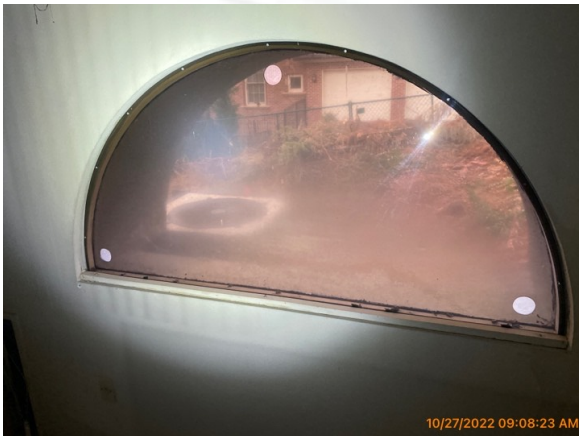
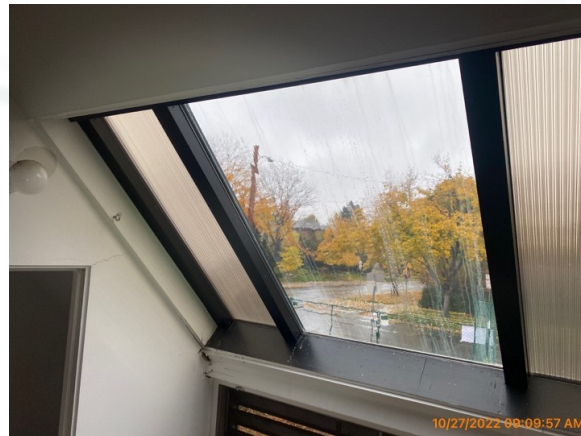
**MAR 8:** Windows were either metal framed double paned glass or plexiglass with two panes. Various windows appeared fogged, leaking, or damaged.

Fogged glass

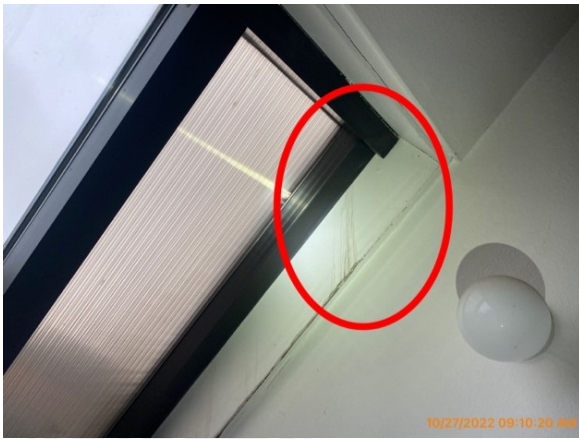
Visible leak

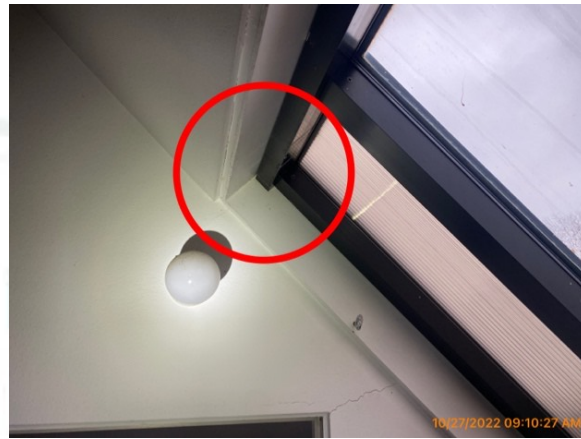
Leaking

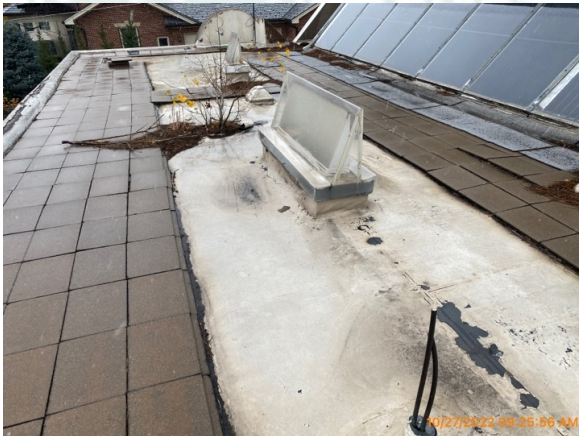
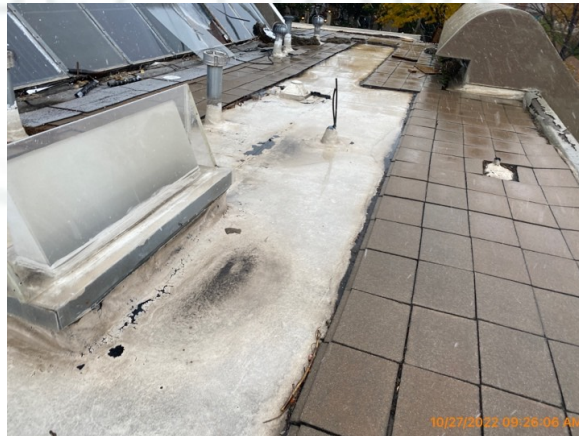
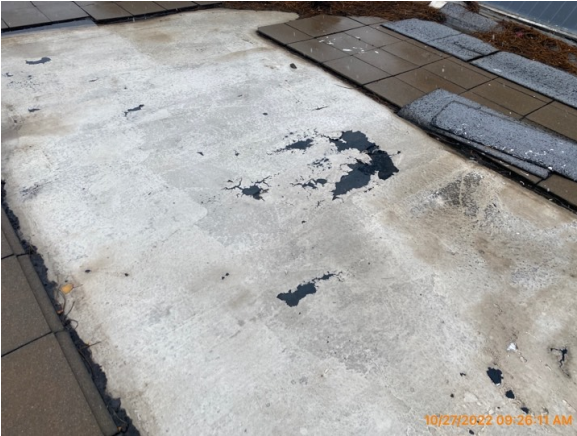
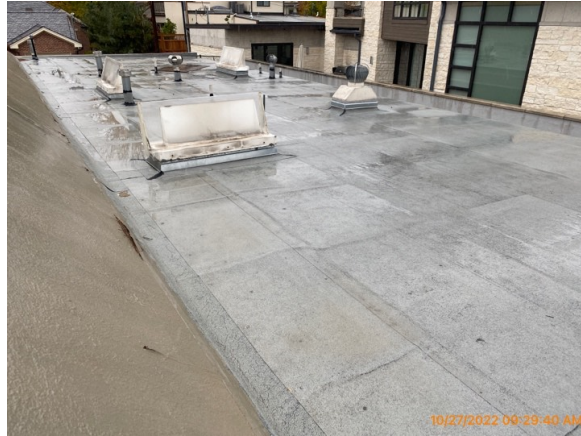
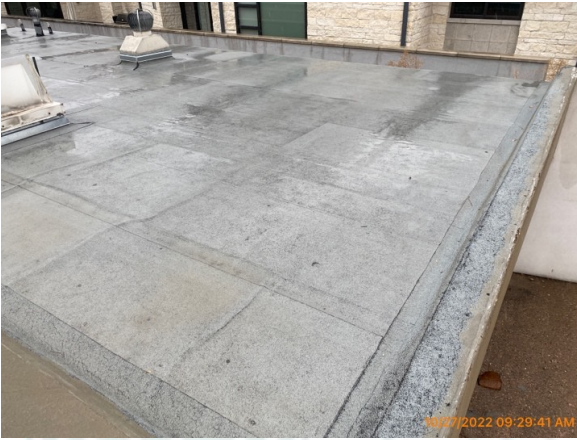
**DEF 11:** Roofing was a membrane covered with paver tiles on south side and rolled composition on north side. Roof materials were in overall poor condition with signs of deterioration at visible areas of membrane. Skylights were deteriorated throughout roof with signs of moisture intrusion.

- The clear story is not properly flashed or the flashing has been severely deteriorated. This has caused rot at the bearing location on the south side, between the upper transition, and corrosion of the solar panel piping. This appears to have been going on for quite some time and requires a complete removal of the clearstory. (Clearstory is located between gridline 2 and 3).

- The southern section of the flat roof was observed to be in overall poor conditions. **The rigid insulation below the membrane was spongy which means that the insulation is damaged and holding water. This requires that the roof membrane and insulation be removed, and the roof sub-structure should be observe for structural performance. We recommend inspection by an experienced roofing contractor.** (Flat roof between grid line 3 and 4)

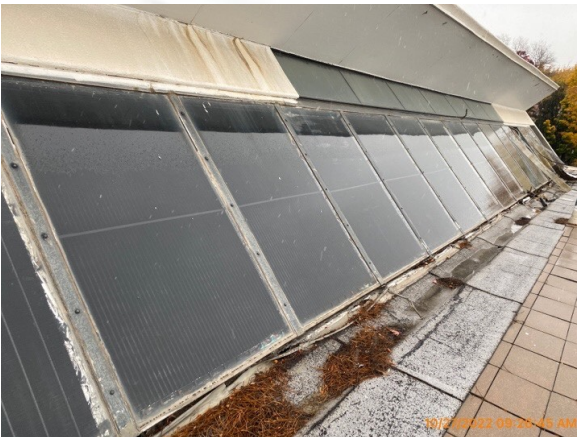
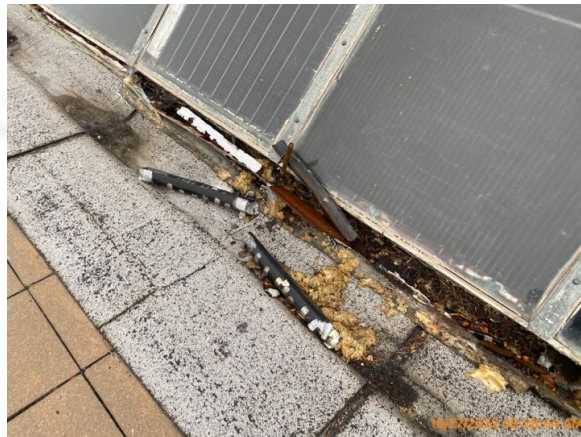
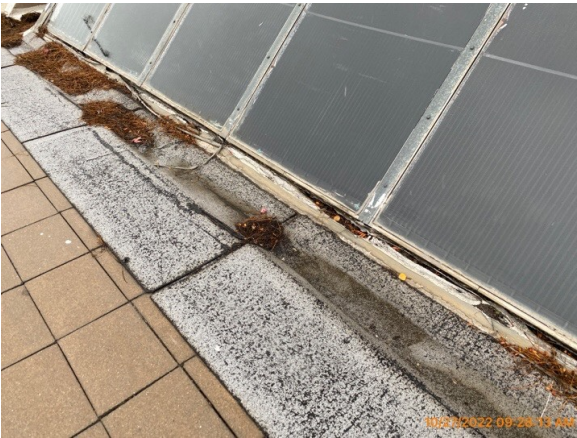
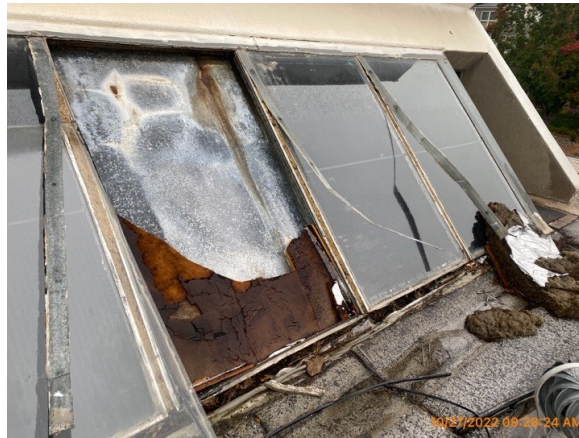
**DEF 12:** Solar heating panels visible on roof. These panels are typically used for heating of water and then stored in water tanks in basement. The panels were in generally poor condition, with panels showing signs of corrosion at pipes and various panels damaged.

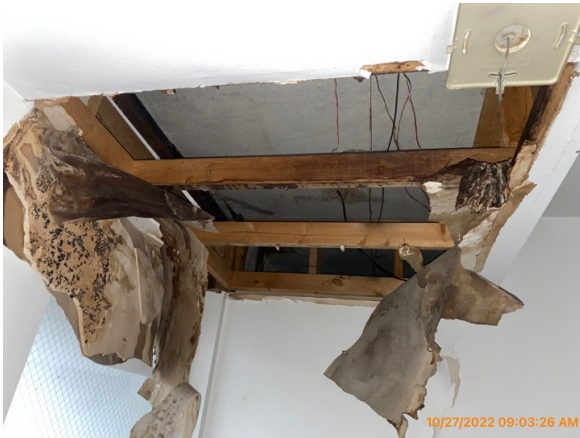
Framed in drop down ceiling with signs of leaks

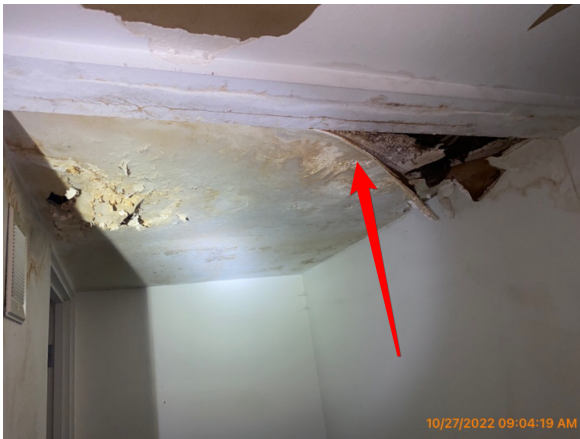
Damage with microbial growth

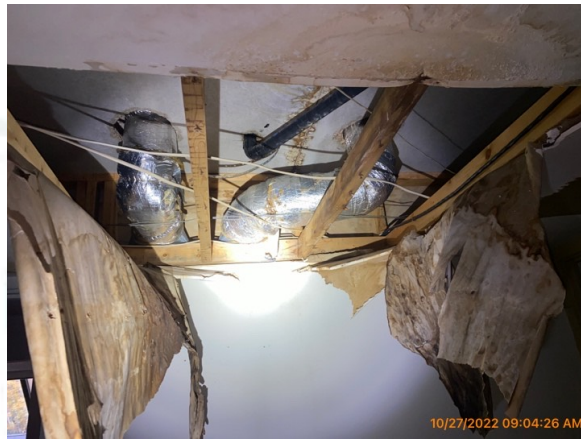
Drop down ceiling with damage and microbial growth

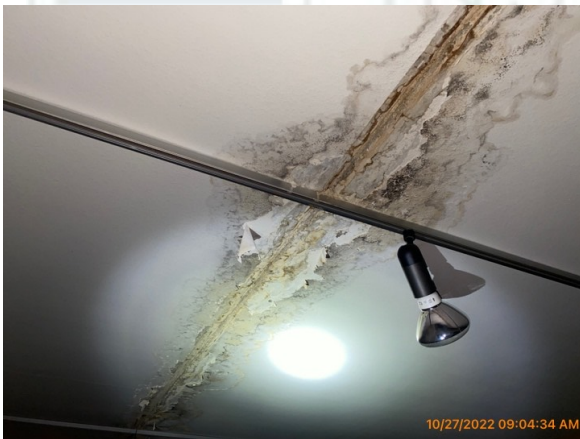
Leak at concrete seam

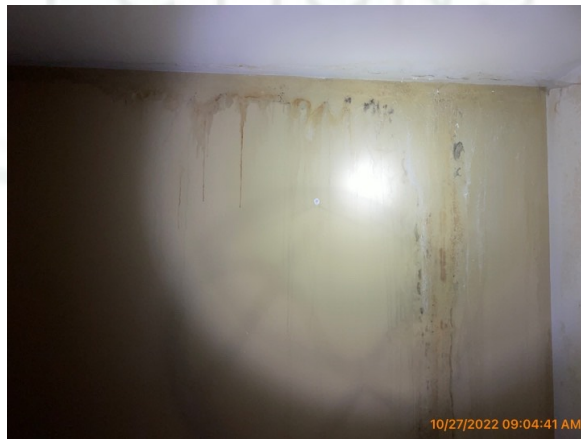
Microbial growth and leak at wall

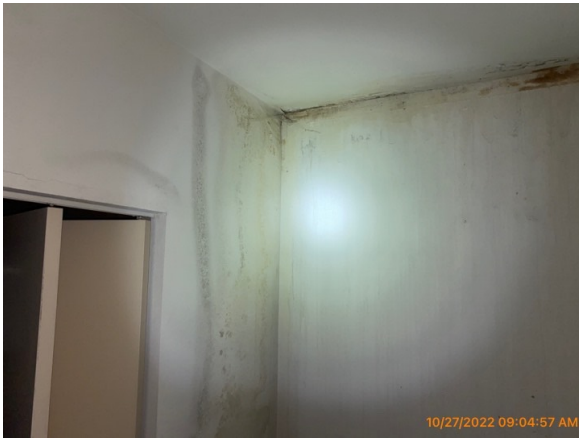
Microbial growth and leak at wall

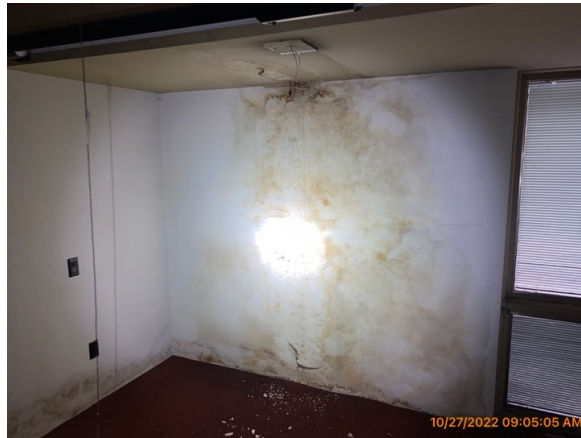
Microbial growth and leak at wall

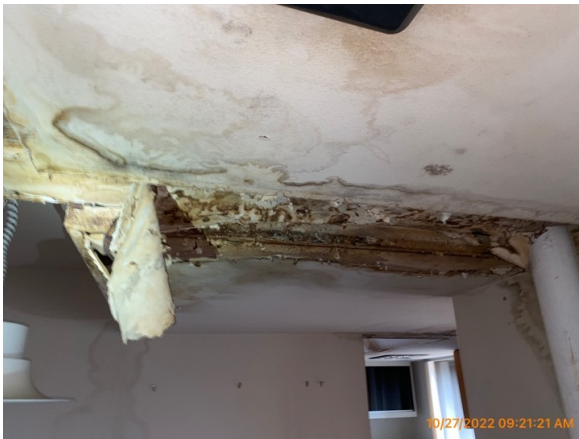
Leak at concrete seam

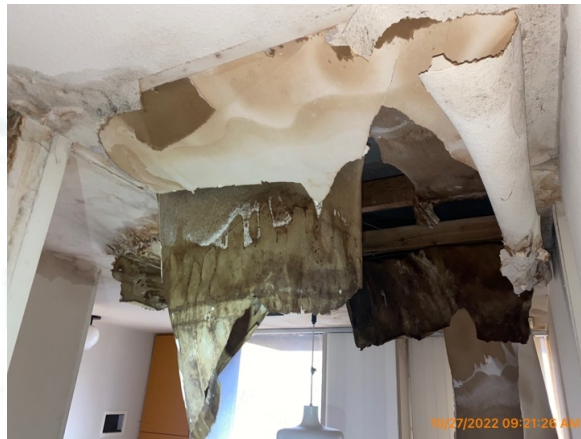
Drop down ceiling with damage and microbial growth

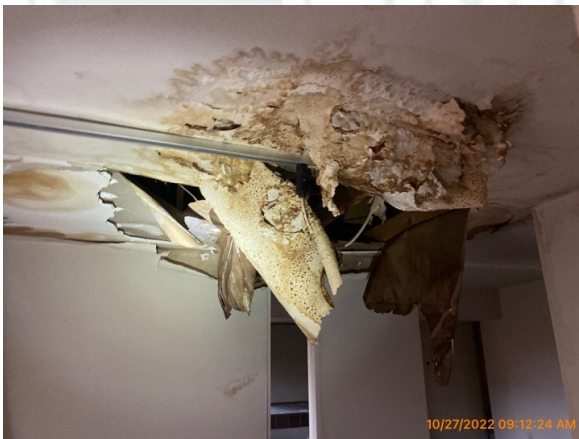
Drop down ceiling with damage and microbial growth

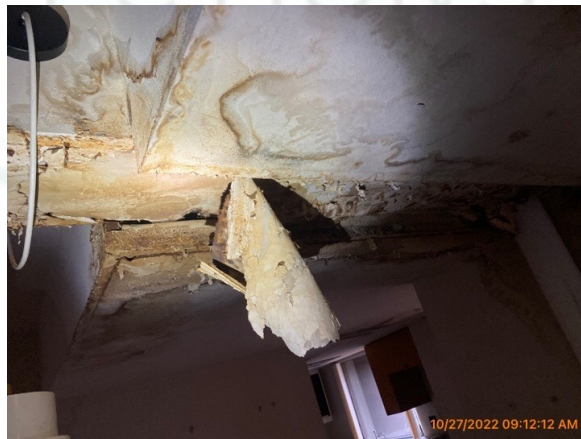
Drop down ceiling with damage and microbial growth

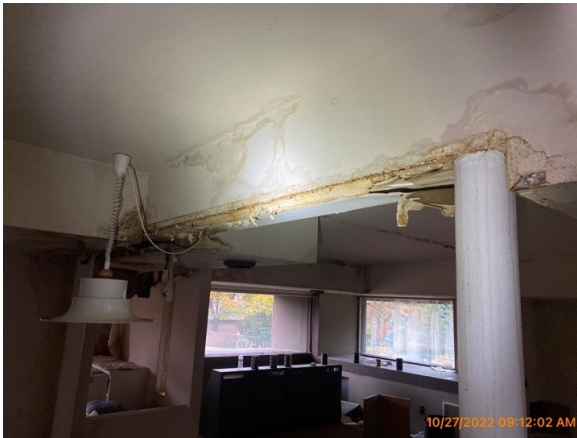
Framed in support beam with signs of leaks
