TAMARAC SQUARE SOUTH BLIGHT STUDY

JANUARY 2012

Tamarac Square South Blight Study

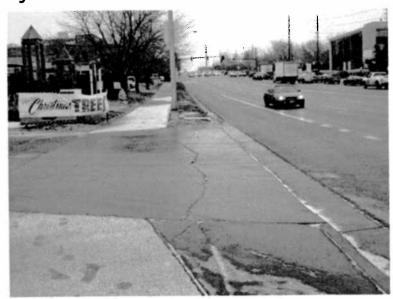
Figure 2-1: Substandard curb cuts and cracked/uneven surfaces for pedestrians

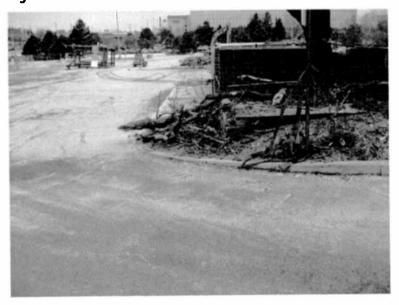
Figure 2-2: Presence of trash and debris

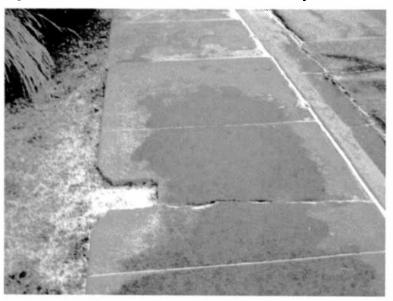
Figure 2-3: Deterioration/lack of site sidewalks/pedestrian areas

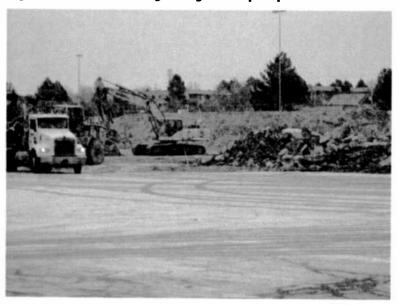
Figure 2-4: Insufficient grading or steep slopes
