# 26th & Larimer Conditions Study

December 2021

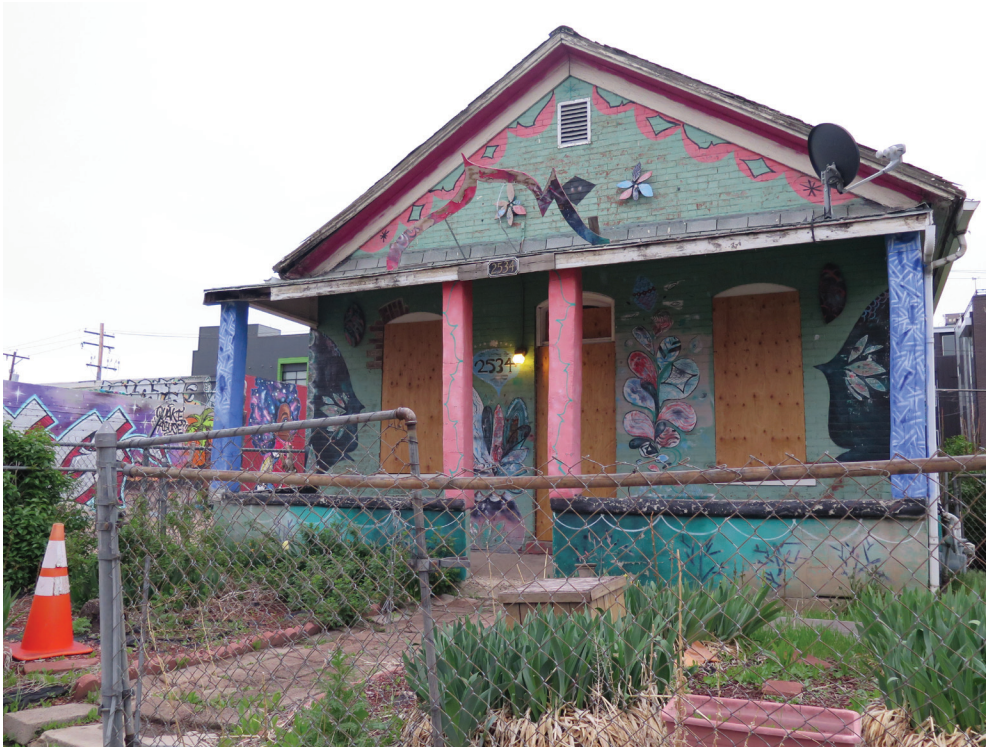
2534 Larimer St

Farther northeast, on the other side of the vacant lot, is a residential property at 2534 Larimer Street (#2 in **Exhibit 3: Property Detail Map**). It dates to 1885, recently sold in 2021, and has long been used as a residential property. It was still occupied at the time of sale, but was boarded during the field survey. An examination of its physical condition revealed deteriorated exterior surfaces, uneven retaining walls, missing and damaged fascia boards with peeling paint, and a deteriorated roof. It was painted around 2016 with bright colors that suggest an eclectic, creative vibe.

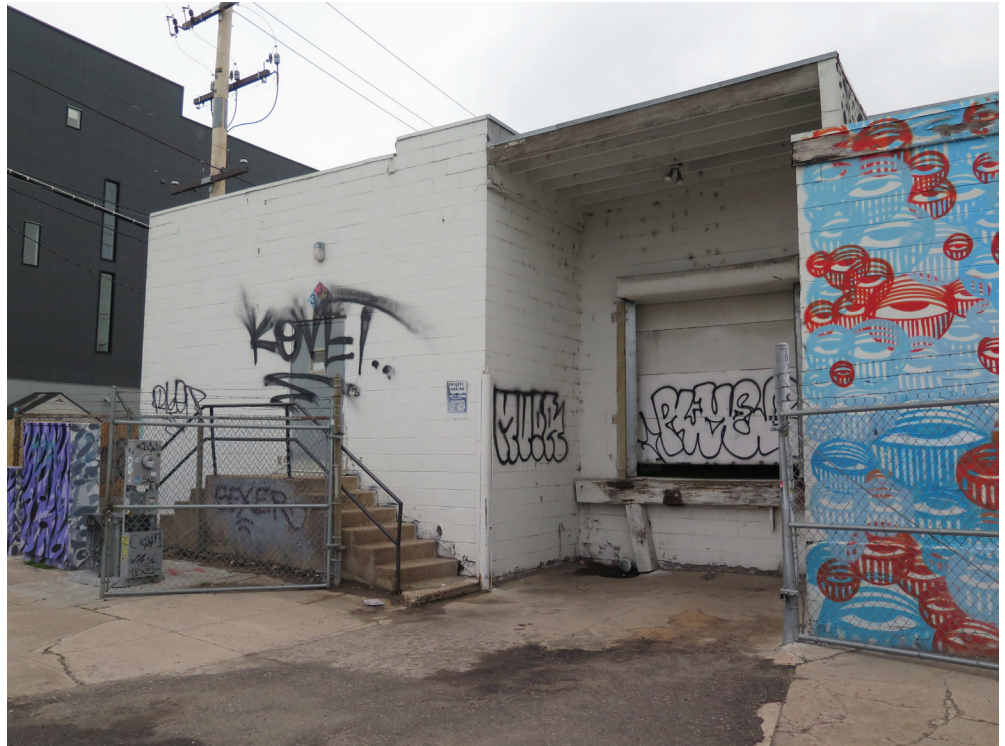
Next at 2550 Larimer Street, (#3 in **Exhibit 3: Property Detail Map**), is a building commonly referred to as the “IMAC Building” due to the signage advertising its tenant, the IMAC Research and Development Center. This building has a street mural painted on its frontage along Larimer and 26th Streets. The mural portion of the building has no glaring maintenance issues, but there is a deteriorated loading dock in the back near the alley along 26th with some graffiti.

*Deteriorated loading dock at the IMAC building*

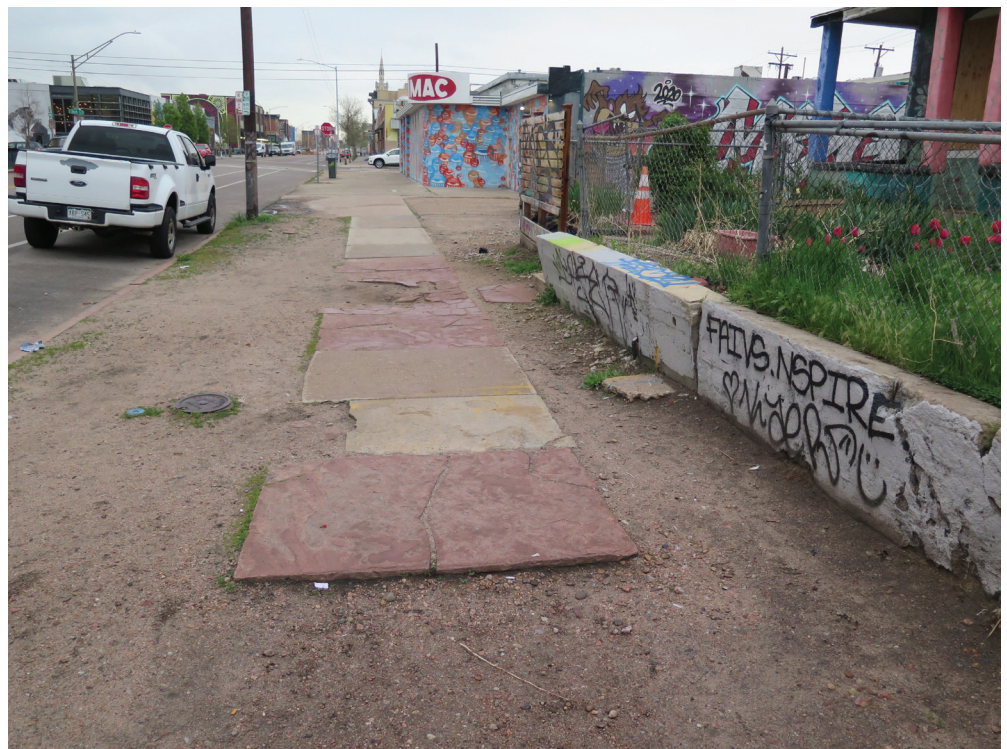
Much of the public space in the Study Area is in good condition, but numerous examples of deteriorating sidewalks were noted, including in areas where the sidewalk looked to be relatively new. One spot in particular, where the flagstone sidewalk in front of the residential property remains, was in particularly bad condition, with severely cracked or missing pieces of flagstone. Vacant lots in the Study Area were sometimes overgrown or had badly deteriorated paved areas, and the residential property was noted to have a deteriorated retaining wall near the sidewalk.

*Missing and damaged flagstone sidewalk sections in front of deteriorated retaining wall*

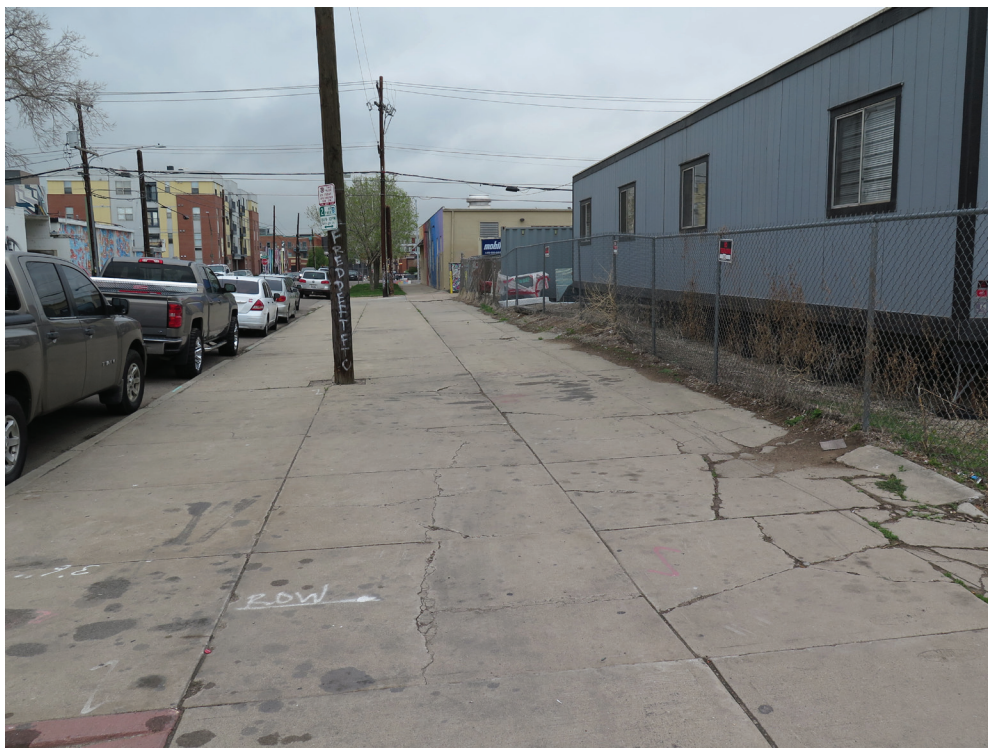
*Lots of cracking in concrete sidewalk*

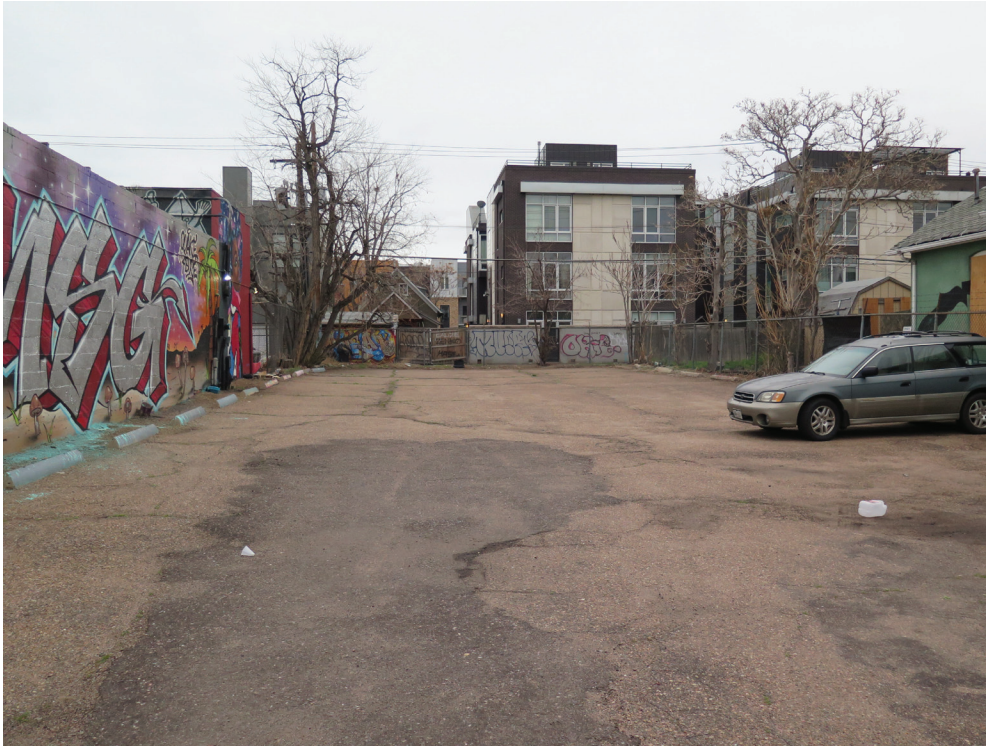
*A private surface lot along Larimer Street*

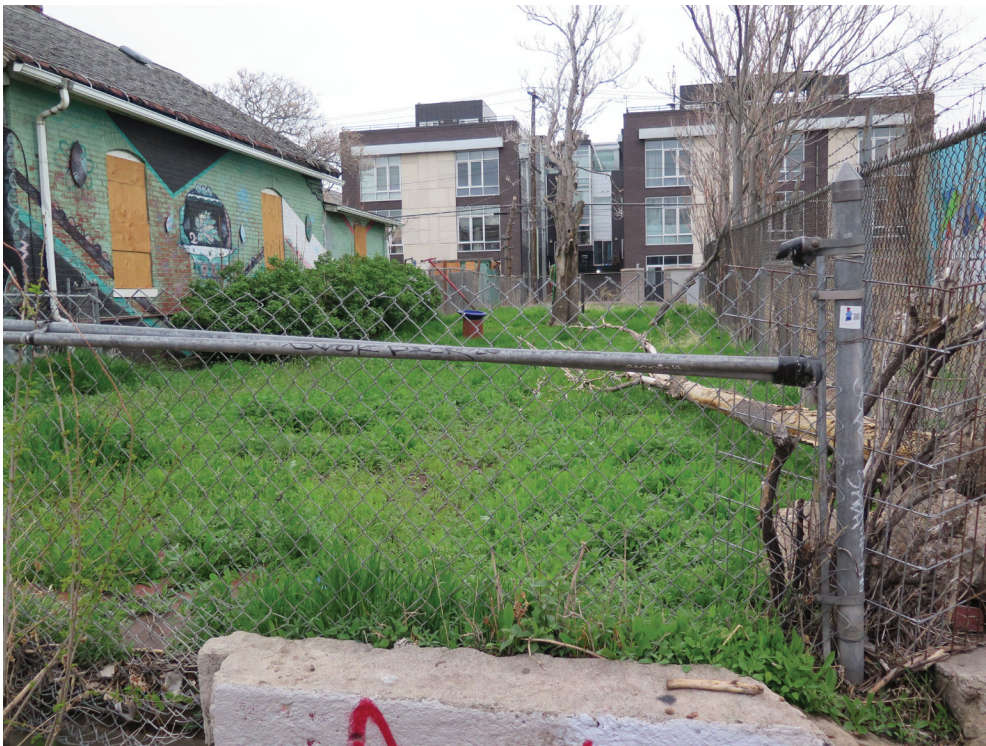
*Vacant lot in the Study Area*
