# 38th & Huron Conditions Study

February 2023

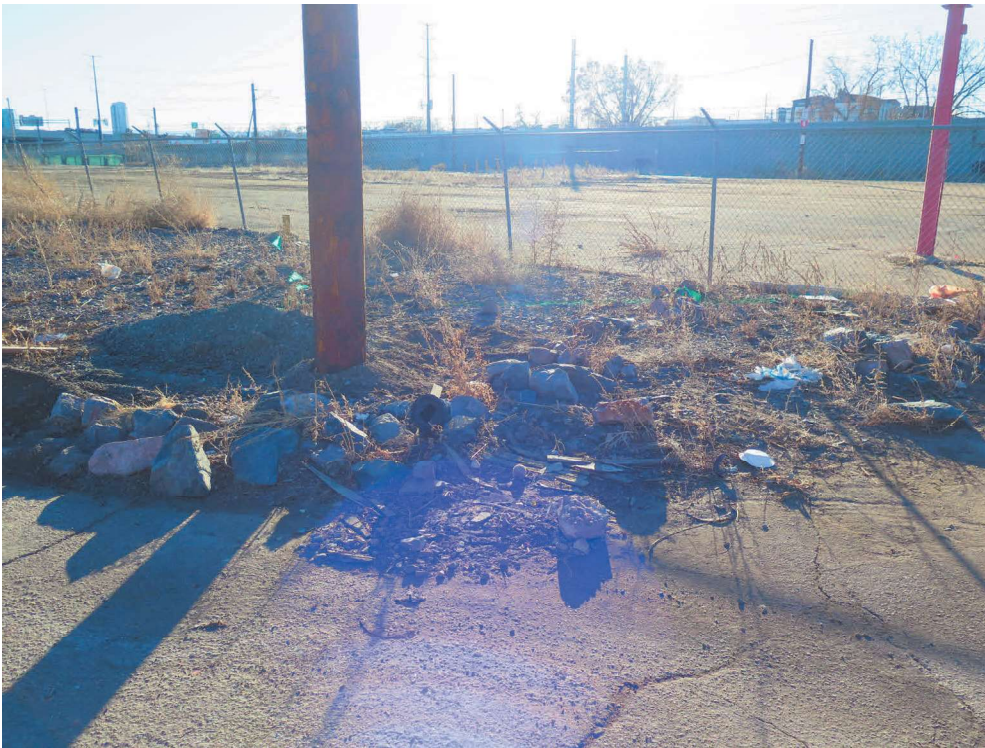
Galapago Street along the property was found to contain trash and overgrown vegetation, as were various locations in the interior of the property.

*The Galapago Street right-of-way adjacent to the Study Area*

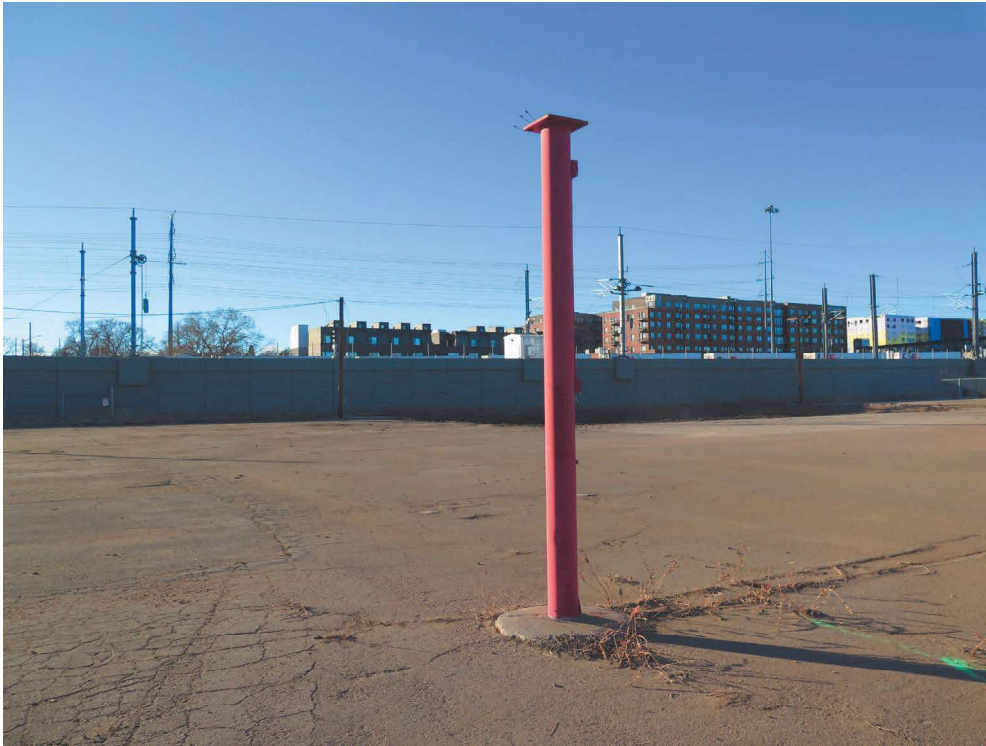
During the 2023 field survey, the Study Area was found to be characterized by uneven grading, especially at locations where buildings formerly stood, slabs of concrete, and cracked asphalt. Occasional deteriorated signs and light poles were also noted.

*Deteriorated signage*

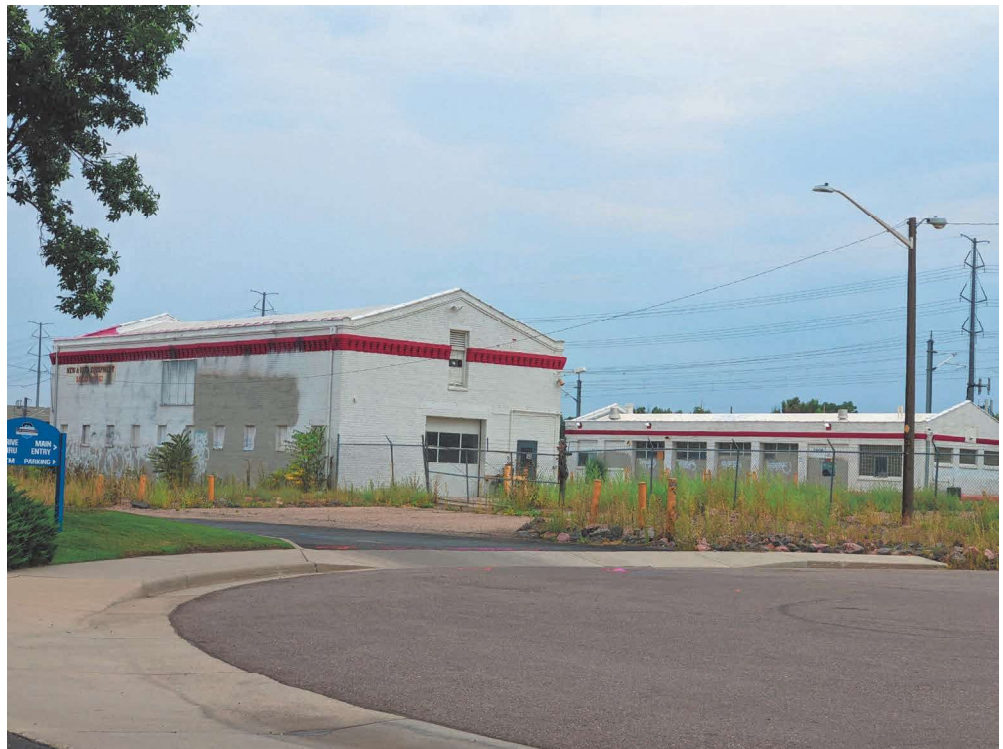
Galapago Street along the eastern boundary of the Study Area lacks sidewalks, curb, and gutter. The adjacent property to the east does have this infrastructure along its borders, which results in a sidewalk along the cul-de-sac that abruptly ends on the western side.

*The cul-de-sac*
