26th & Larimer Conditions Study

December 2021

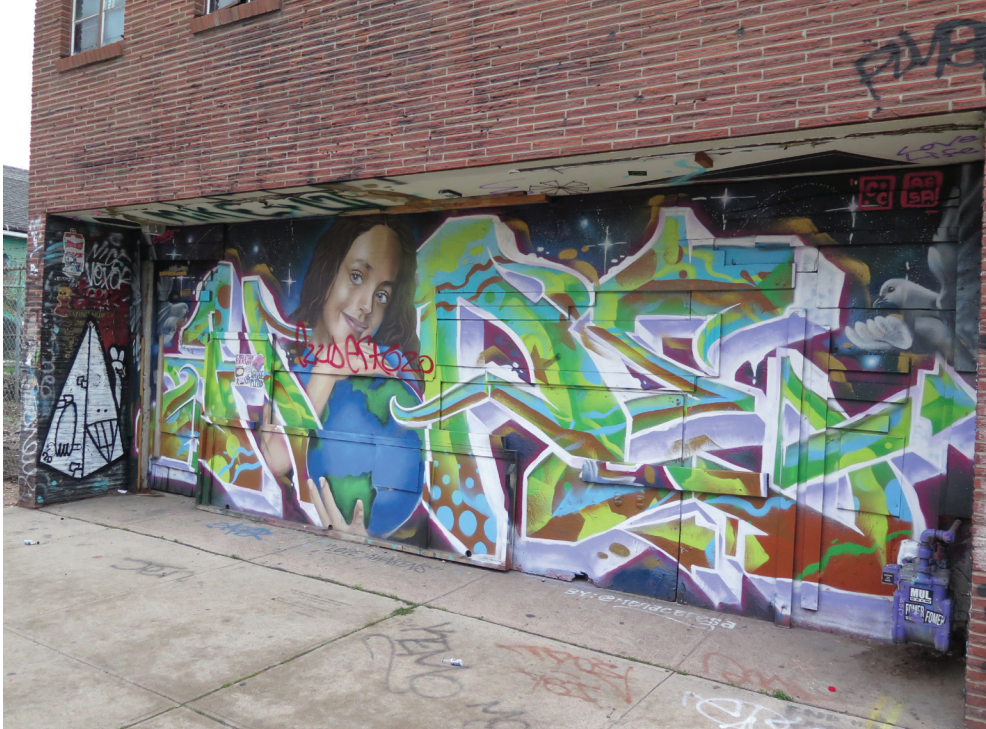
2524 Larimer St

At the southern end of the Study Area, 2524 Larimer St, (#1 in **Exhibit 3: Property Detail Map**), is a long-vacant warehouse property with deteriorating soffits and a mix of street art and some graffiti across its boarded front as well as its northeast side facing the adjacent vacant lot.

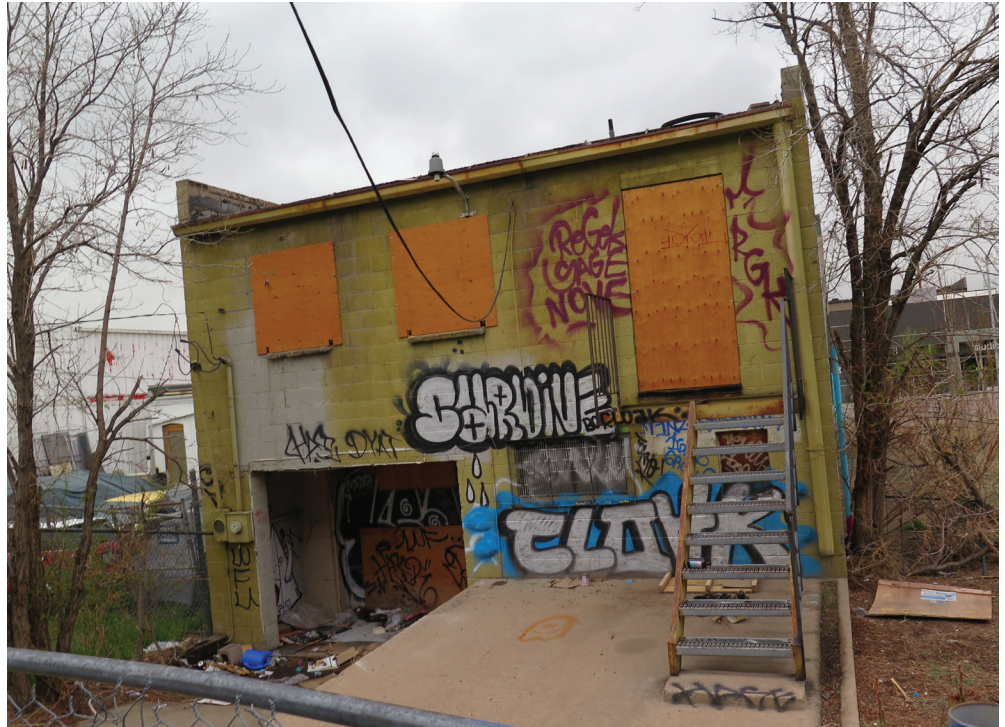
The rear of the warehouse building has more graffiti, boarded windows, a boarded door, and a boarded loading dock. There is also a deteriorated metal staircase missing a railing and missing a floor on the landing at the top.

Rear of the warehouse building

As mentioned, the warehouse at 2524 Larimer Street has a deteriorated and defective staircase at its rear exit. This is too dangerous to use without a solid floor at the top landing. While this qualifies as an example of blight under this factor, it is simply too minor of an issue that can be fixed too easily to tip the balance in favor of a positive finding for the Study Area as a whole. The building is also completely boarded to prevent trespassing and use of this stairway.

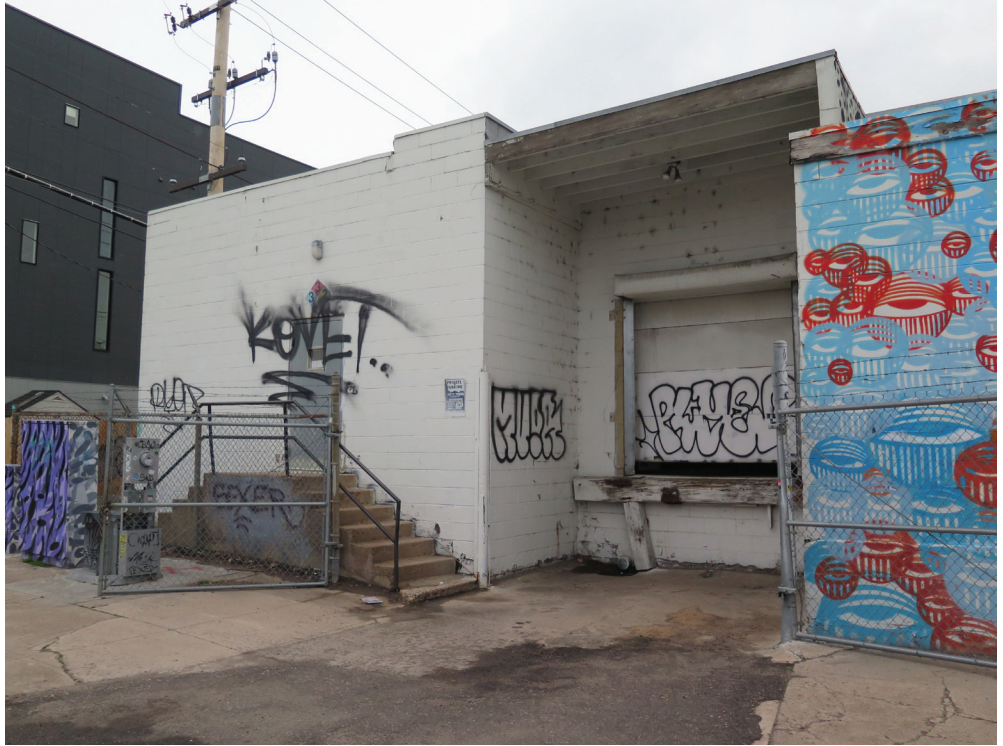
Next at 2550 Larimer Street, (#3 in **Exhibit 3: Property Detail Map**), is a building commonly referred to as the “IMAC Building” due to the signage advertising its tenant, the IMAC Research and Development Center. This building has a street mural painted on its frontage along Larimer and 26th Streets. The mural portion of the building has no glaring maintenance issues, but there is a deteriorated loading dock in the back near the alley along 26th with some graffiti.

Deteriorated loading dock at the IMAC building

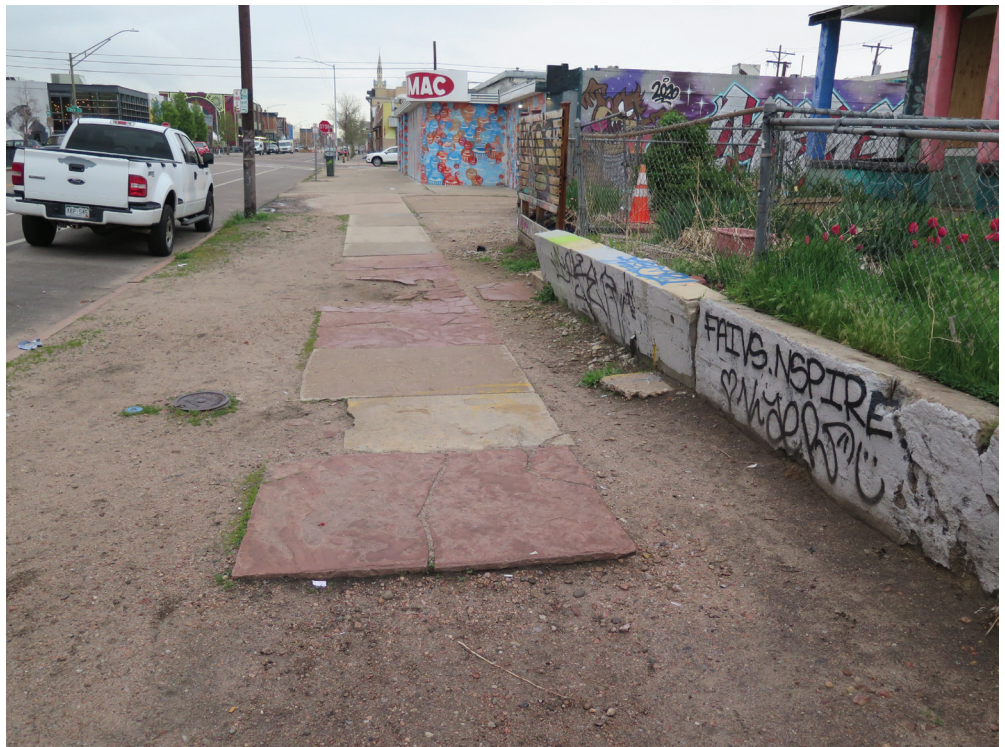
Much of the public space in the Study Area is in good condition, but numerous examples of deteriorating sidewalks were noted, including in areas where the sidewalk looked to be relatively new. One spot in particular, where the flagstone sidewalk in front of the residential property remains, was in particularly bad condition, with severely cracked or missing pieces of flagstone. Vacant lots in the Study Area were sometimes overgrown or had badly deteriorated paved areas, and the residential property was noted to have a deteriorated retaining wall near the sidewalk.

Missing and damaged flagstone sidewalk sections in front of deteriorated retaining wall

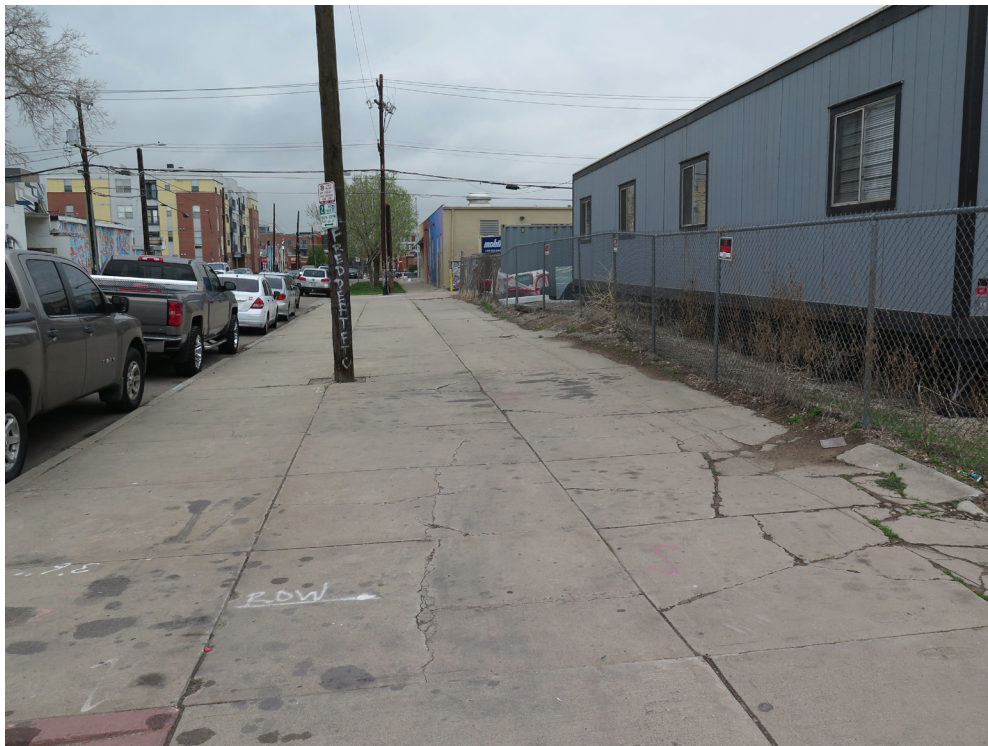
Lots of cracking in concrete sidewalk

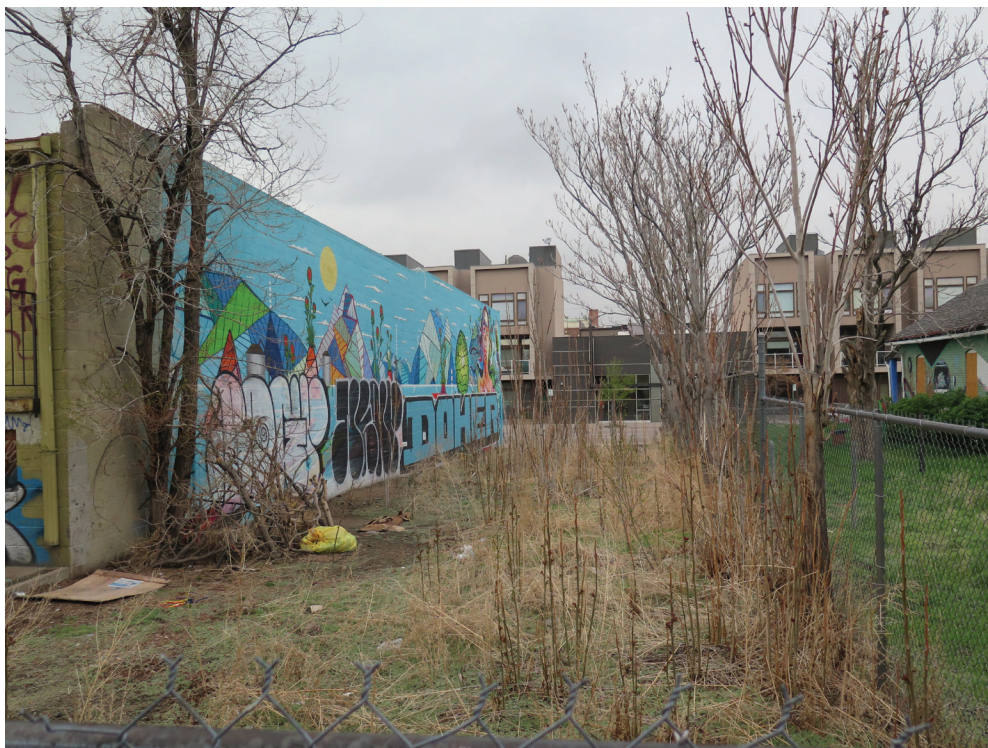
Vacant lot with overgrown vegetation

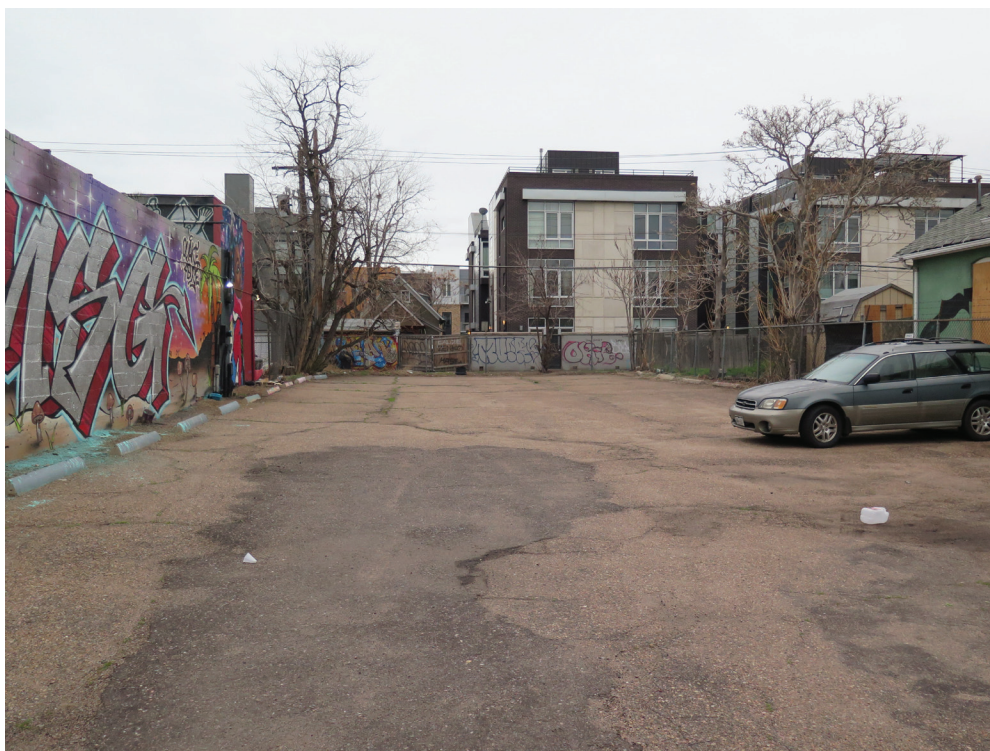
A private surface lot along Larimer Street

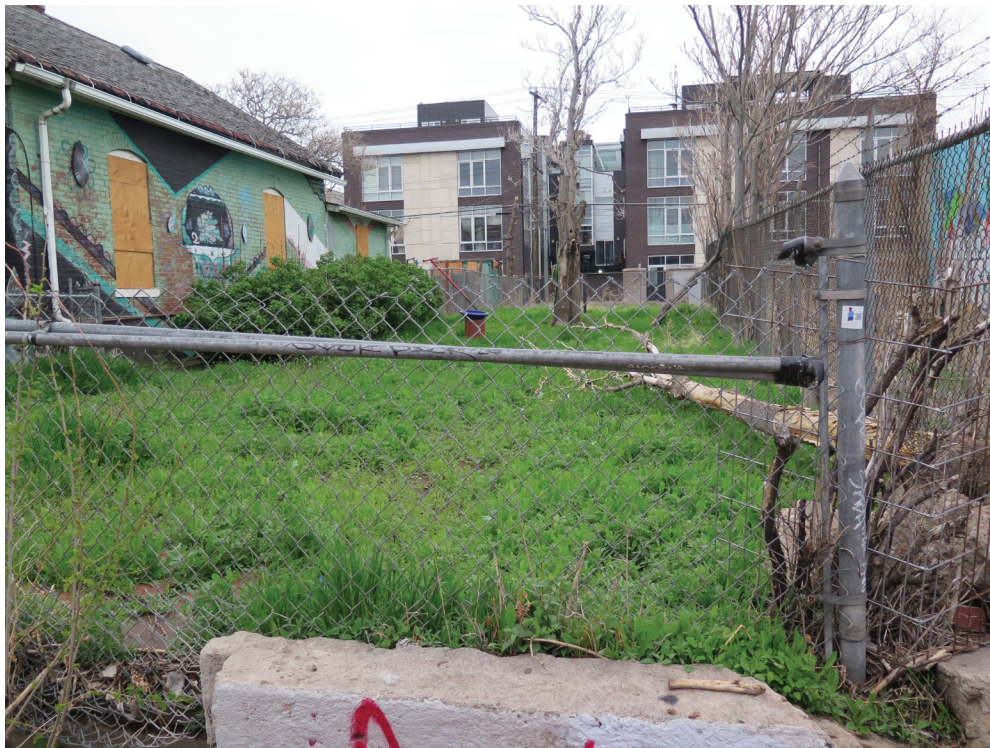
Vacant lot in the Study Area

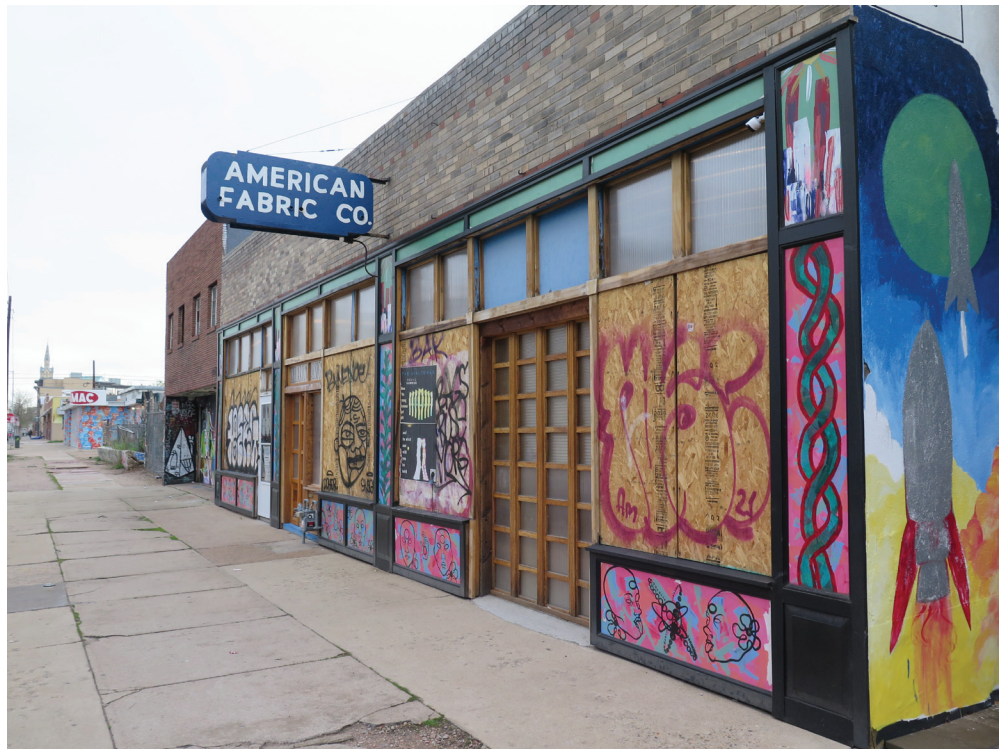
Underutilized tenant spaces along Larimer Street

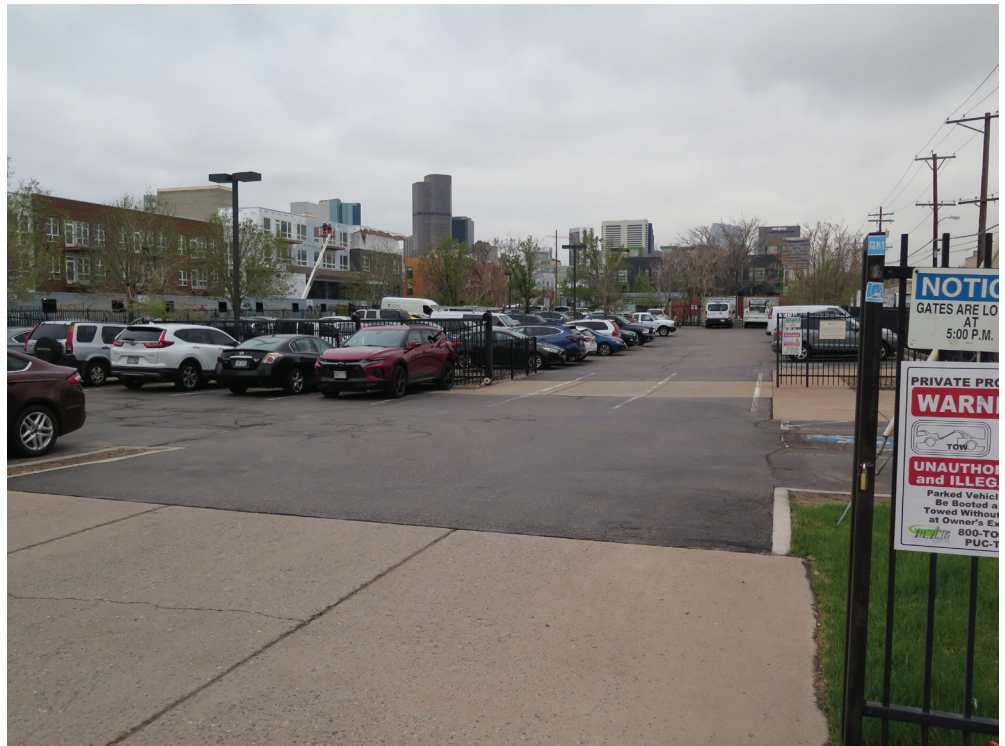
The entire 2600 block along Lawrence Street is used for surface parking
