# 38th & Huron Conditions Study

February 2023

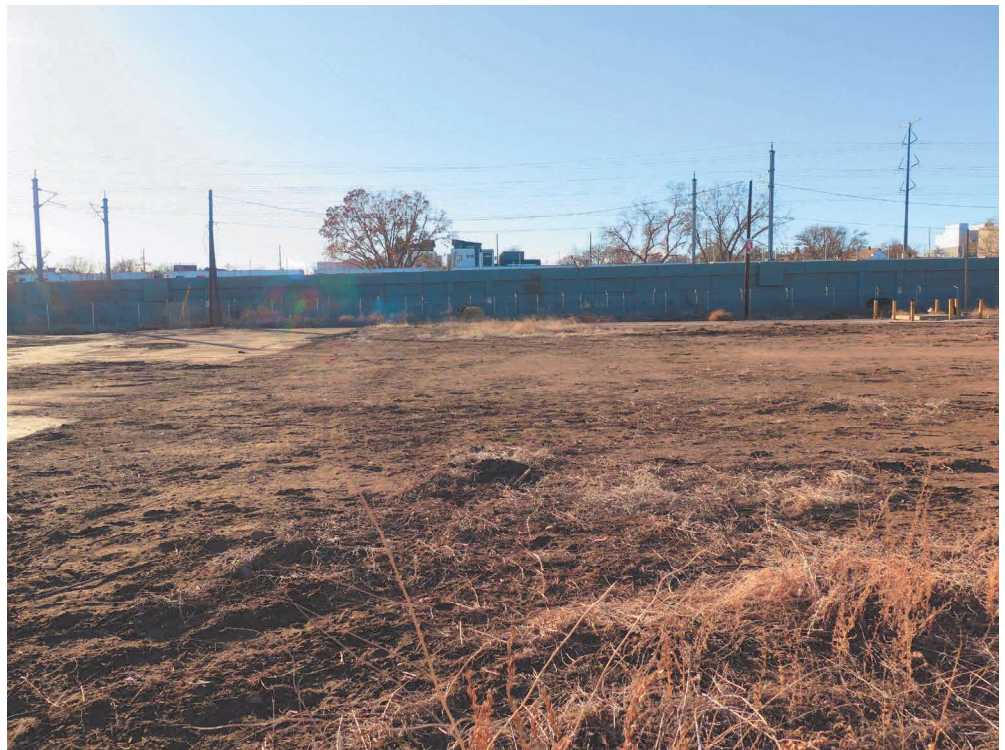
The three structures that formerly existed in 2022 in the Study Area were found to have been completely razed at the time of the most recent field survey in February 2023. The satellite imagery used in **Exhibit 1** is not recent enough to reflect this.

Since no structures exist any longer in the Study Area, there **is no finding of Slum, Deteriorated, or Deteriorating Structures**.

*The Study Area contains no vertical development*

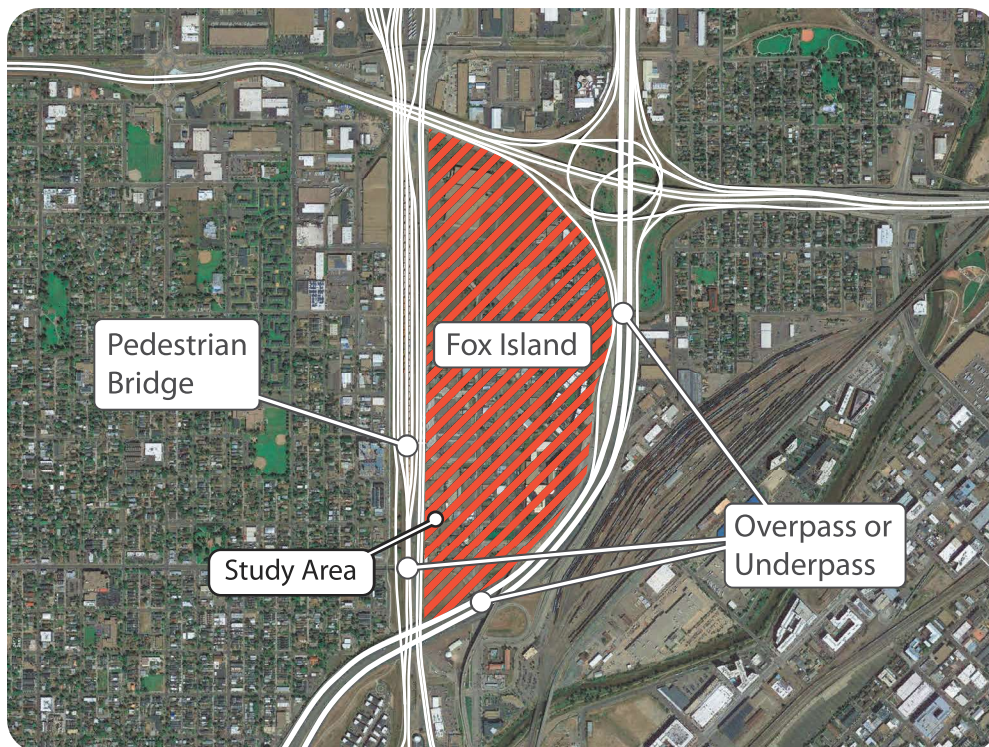
The 38th & Huron Study Area is located in the physically separate urban “island” (Fox Island) created by two interstate highways and a rail corridor. This area only has two places of ingress/egress by automobile, the 44th Avenue bridge over I-25 to the east and the 38th Street/Park Avenue interchange with I-25 at the southern end.

Access to other parts of Globeville to the north is particularly poor, as there are no crossings of Interstate 70 nearby.

*The Study Area is located in a physically isolated “urban island”*

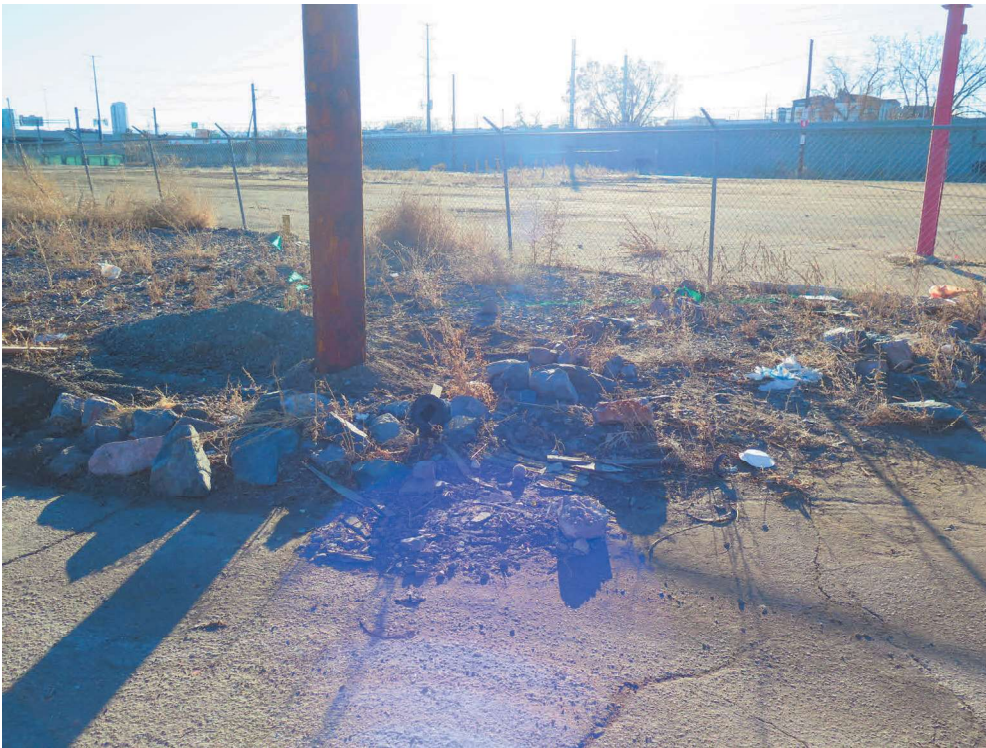
Galapago Street along the property was found to contain trash and overgrown vegetation, as were various locations in the interior of the property.

*The Galapago Street right-of-way adjacent to the Study Area*

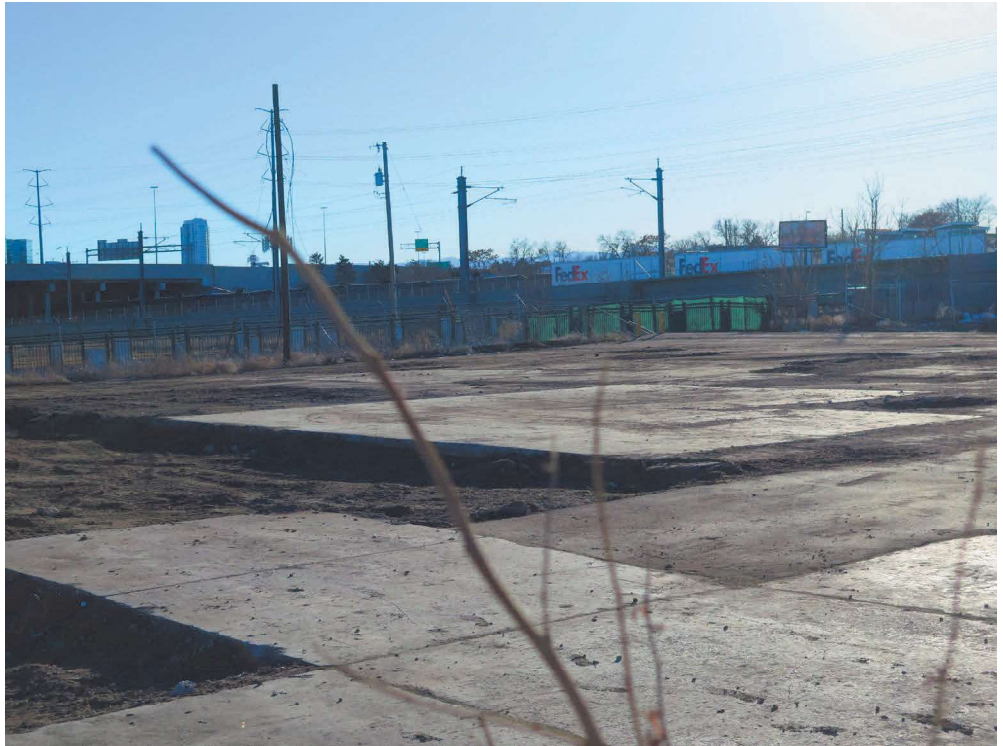
During the 2023 field survey, the Study Area was found to be characterized by uneven grading, especially at locations where buildings formerly stood, slabs of concrete, and cracked asphalt. Occasional deteriorated signs and light poles were also noted.

*Concrete slabs with uneven grading*

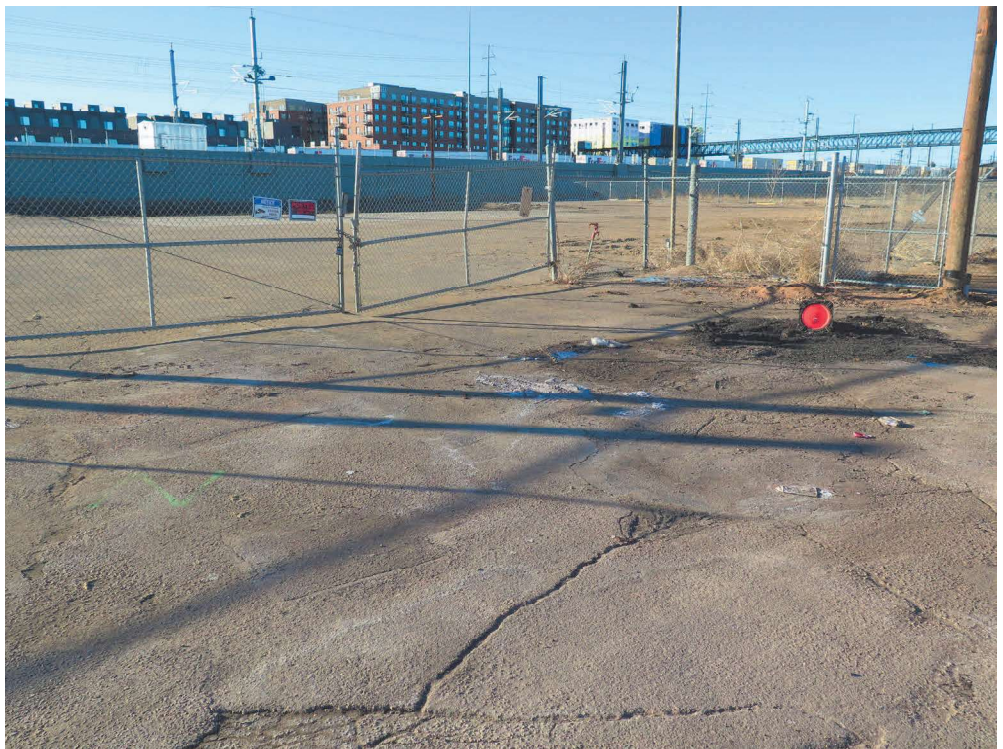
*The entrance to the Study Area*

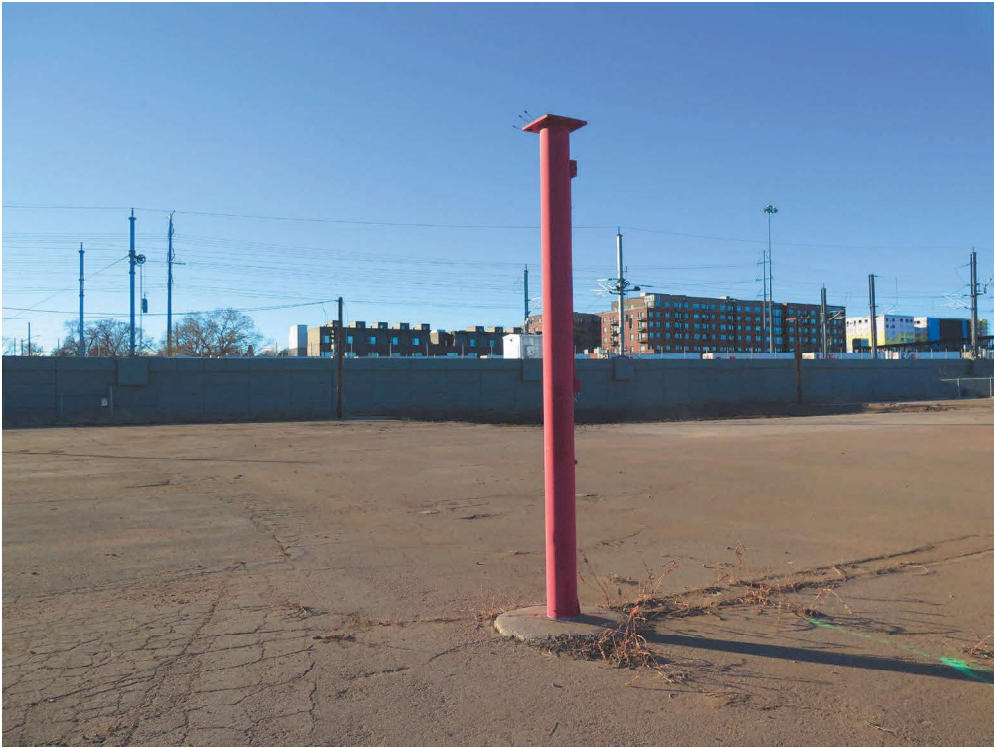
*Deteriorated signage*

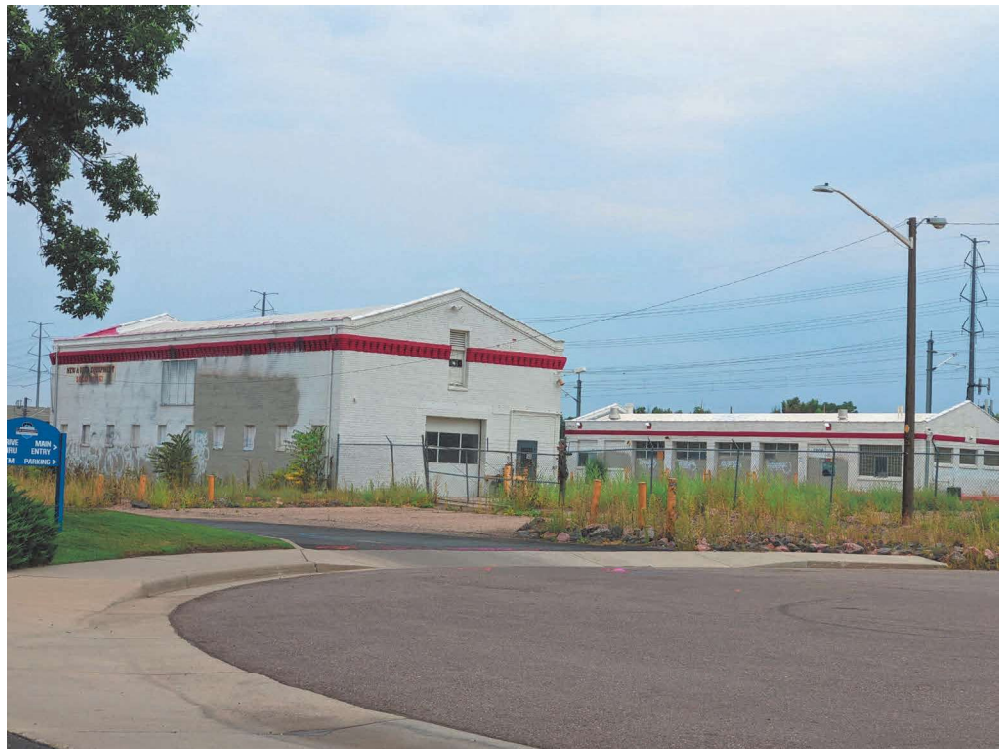
Galapago Street along the eastern boundary of the Study Area lacks sidewalks, curb, and gutter. The adjacent property to the east does have this infrastructure along its borders, which results in a sidewalk along the cul-de-sac that abruptly ends on the western side.

*The cul-de-sac*

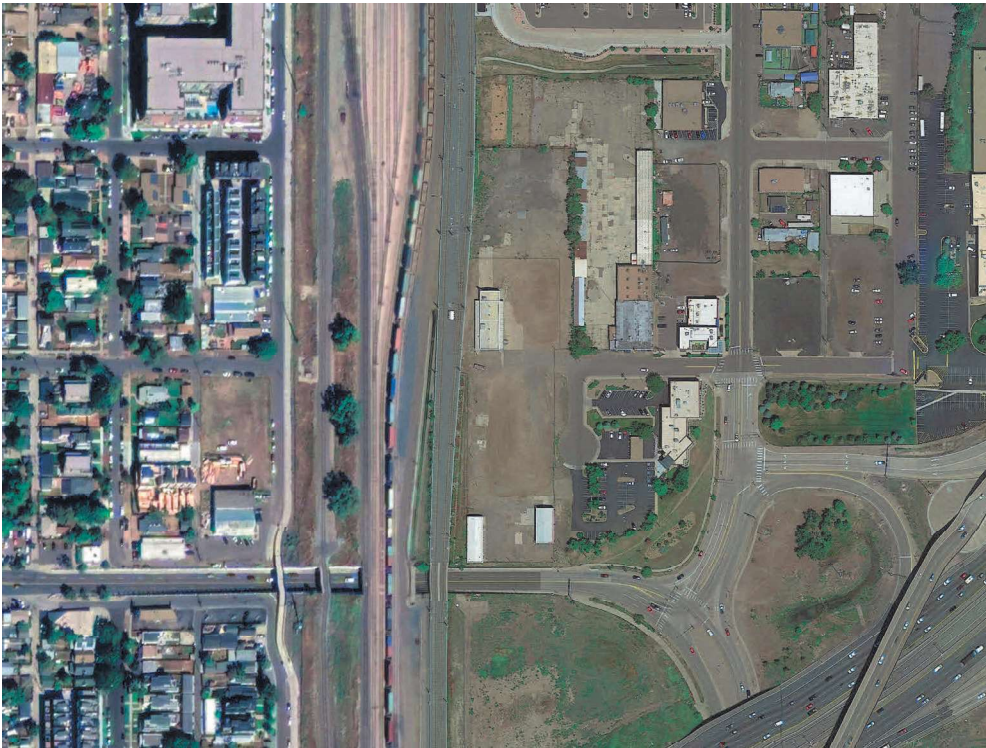
In short, visioning and planning efforts thus far see a potential for the Study Area to contain far higher development intensity than exists today, a vacant 3-acre lot.

*A 2021 aerial centered on the Study Area*
