# Emily Griffith Technical College Conditions Study

July 2017

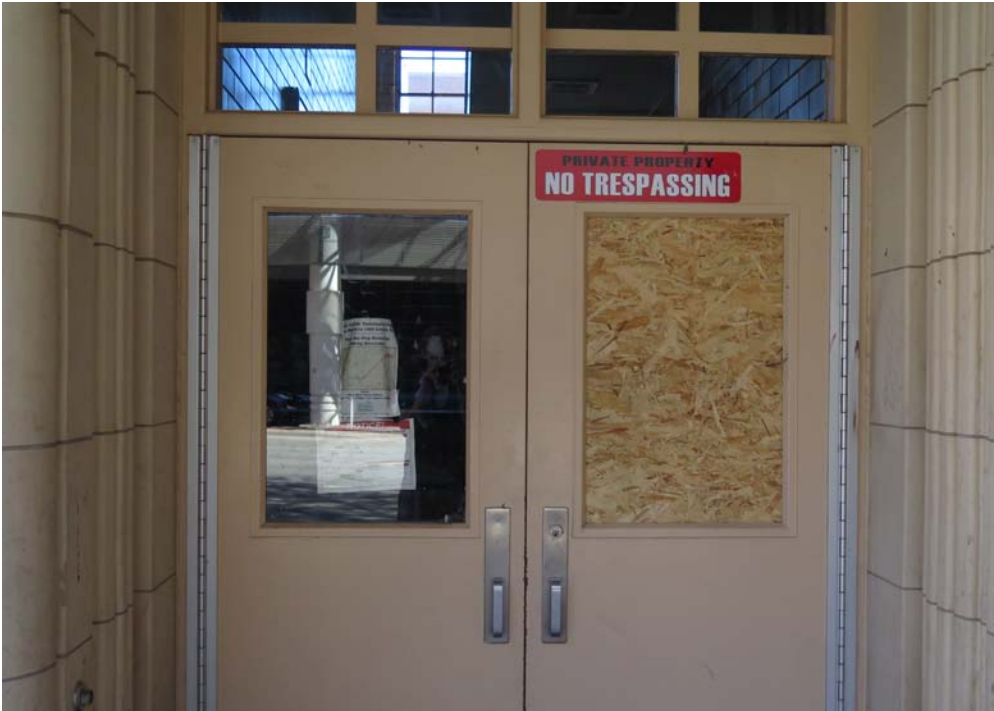
At the time of the field survey performed in September 2016, structures in the Study Area were found to be in fair condition; most issues found were related to broken windows in the school buildings. These broken windows were fairly widespread, but all had been boarded, suggesting that ongoing maintenance is still occurring despite the vacancy of the campus.

Overall, the broken windows in the Study Area contributed to a sense of neglect, but the ongoing boarding of any broken windows has prevented the issue from becoming a safety issue due to broken glass and vagrants trespassing on the property. Nevertheless, as time progresses, the frequency of broken windows continues to increase, and the campus buildings become increasingly dilapidated. The former campus has been closed for about a year, and nearly a dozen broken windows now exist.

*Boarded window at north entrance to Emily Griffith property*

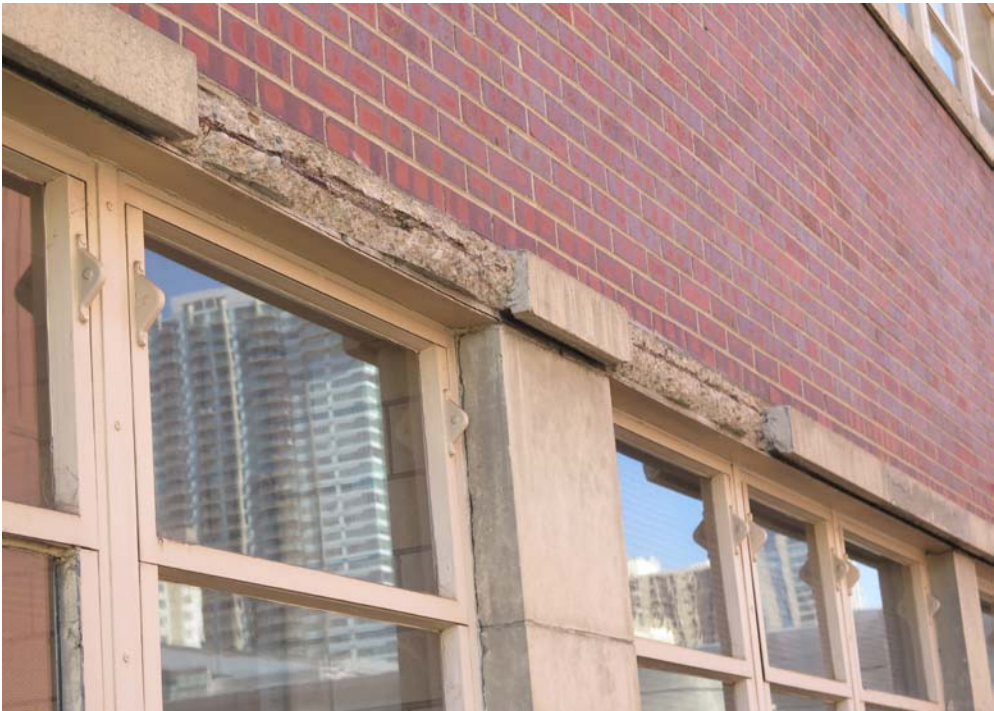
An additional area of concern was noted with the concrete window lintels, which were severely crumbled in many locations, creating small piles of rubble on the ground underneath them.

*Deteriorated exterior elements above windows at Emily Griffith property*

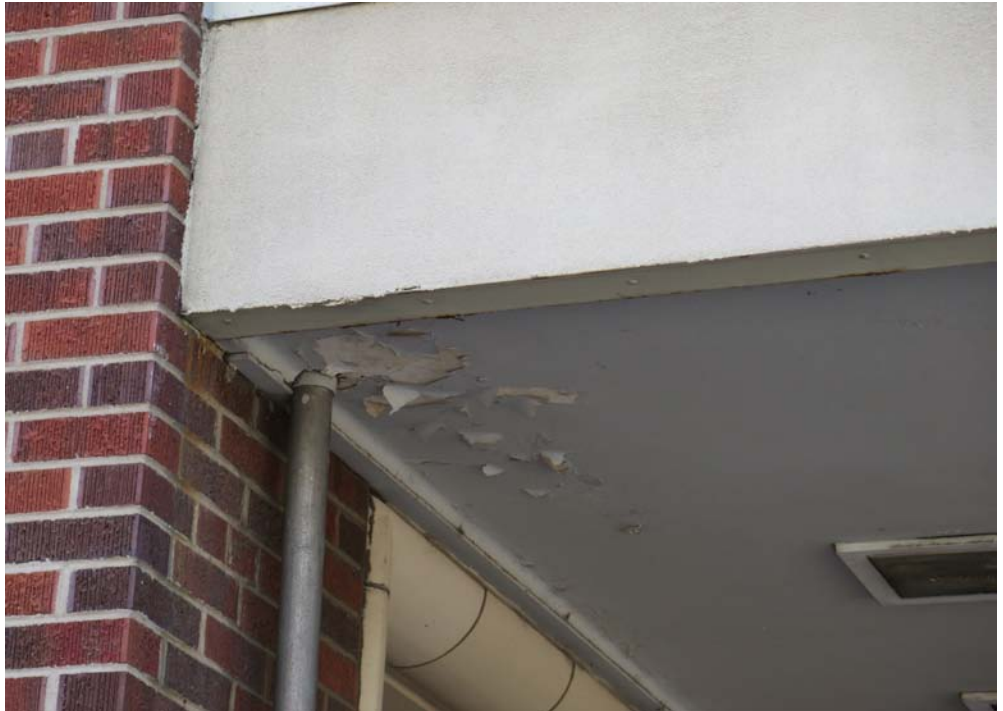
*Peeling paint at Emily Griffith property*

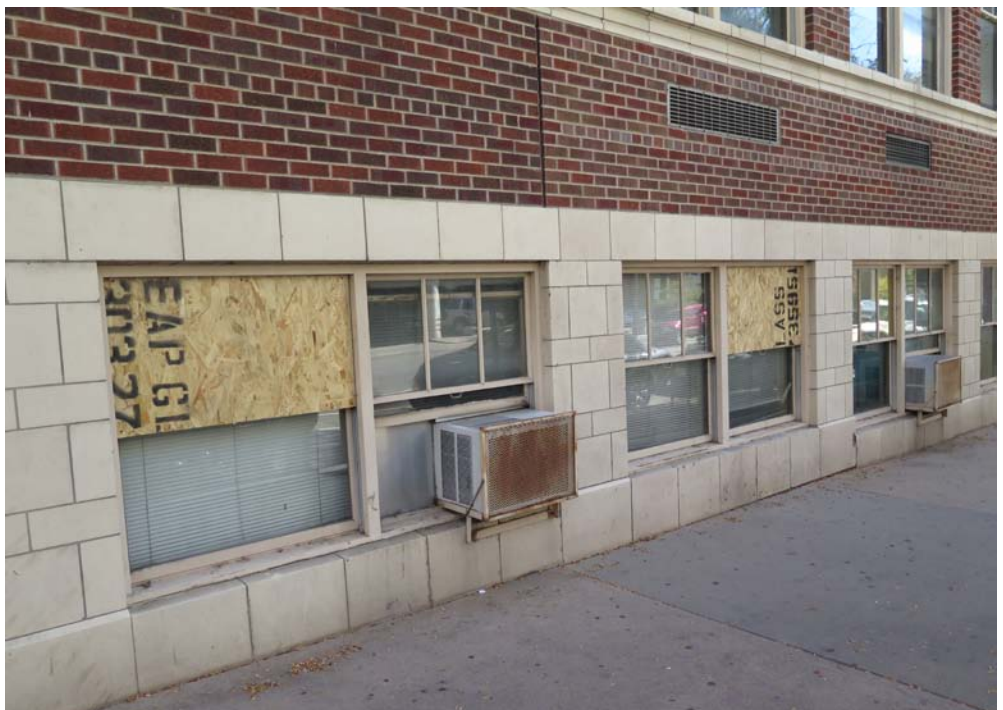
*Broken windows at Emily Griffith property*

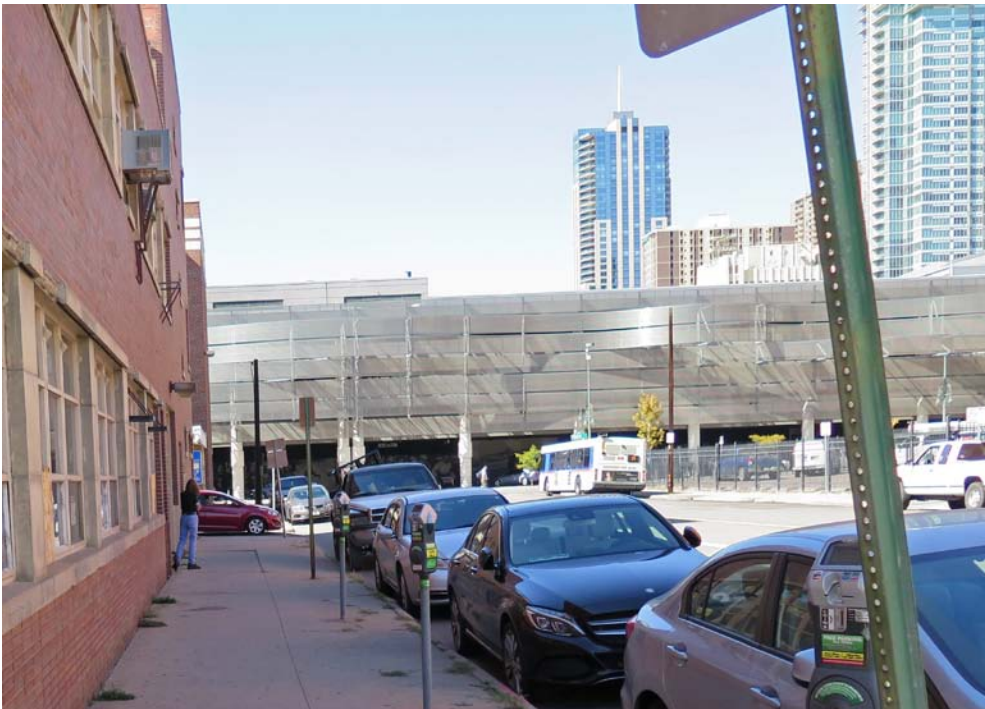
There is relatively poor circulation in the vicinity of the Study Area relative to the rest of the Central Business District and Civic Center area. The Study Area is immediately adjacent to the Colorado Convention Center, which is a sprawling structure occupying more than six full city blocks. The sheer size of the convention center breaks the continuity of the street grid in the area with the exception of Stout Street, which passes underneath the convention center but does not serve any of the property in the Study Area. The Convention Center is one of the largest “superblocks” in the downtown area (a block larger than a single City block), but it is also important to note the presence of the Lindsey-Flanigan Courthouse and Van Cise-Simonet Detention Center to the south, as well as the Denver Center for Performing Arts and the Auraria Campus in the vicinity to the west; all three properties also break the continuity of the street grid, creating dead ends and a lack of redundancy that funnels traffic onto certain streets and creates longer walking distances for pedestrians.

*The convention center, the size of six city blocks, breaks up the street grid and forms a barrier along the northwestern edge of the Study Area*

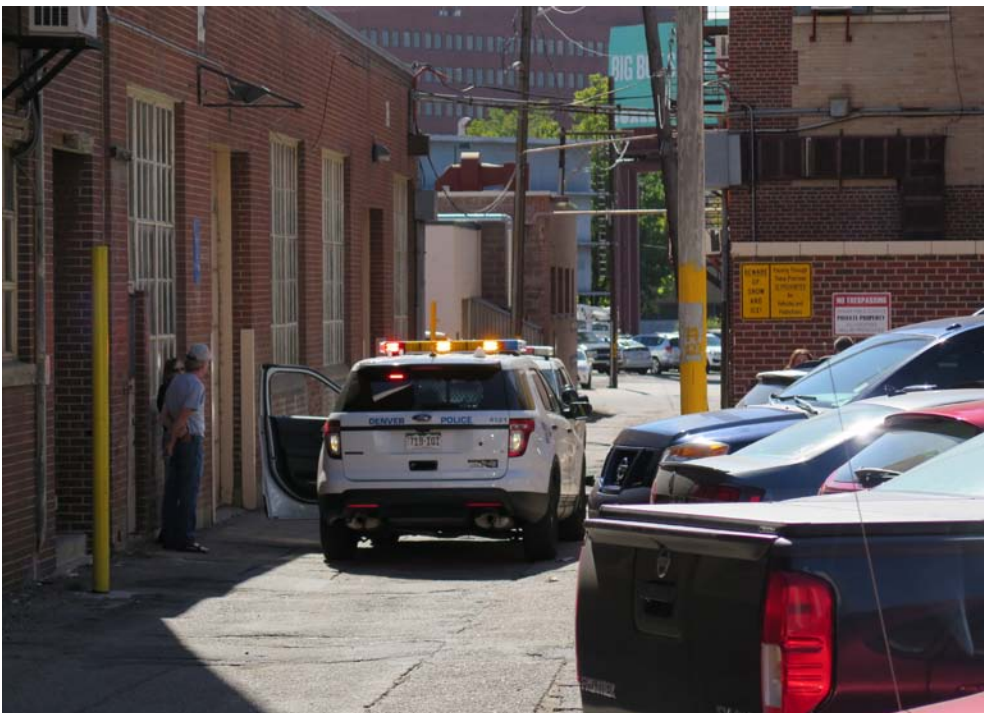
Records from the Denver Police Department show that over the past five years (January 1, 2012 - July 12, 2017), there were 115 reported crimes in the Study Area and in the surrounding rights-of way, not including minor traffic incidents. Emergency responses are more frequent still; one was observed during the field survey but never recorded as a reported crime.

*Emergency responses are relatively common in the Study Area*

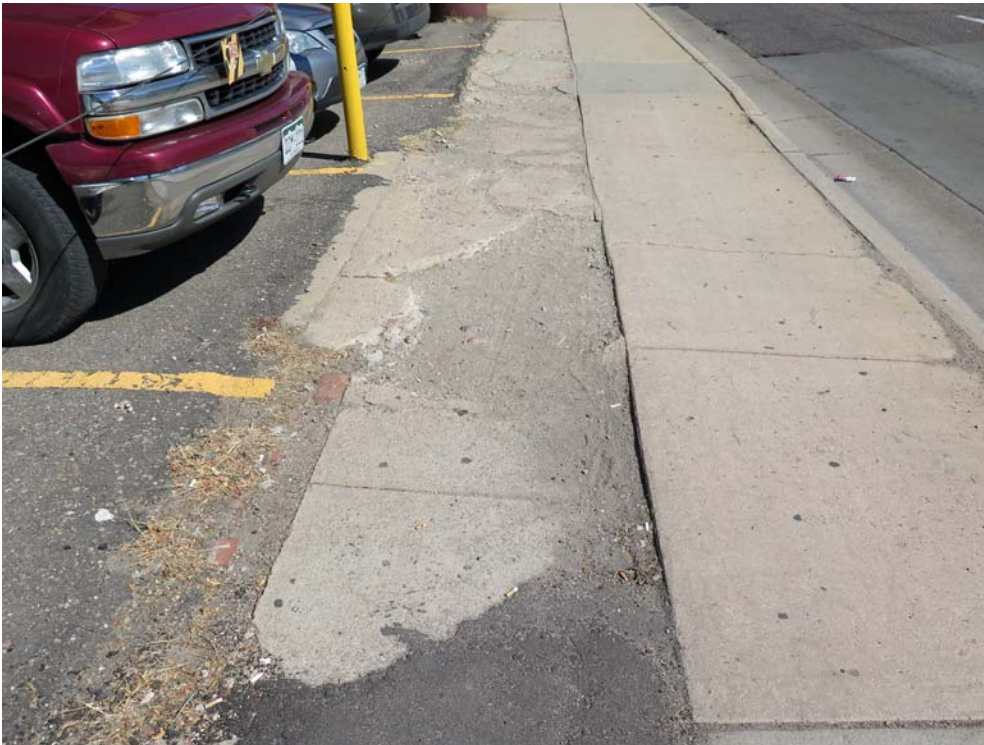
There was one section of sidewalk along the northern edge of Colfax Avenue near the Study Area that was noted to be in need of repair, but otherwise sidewalks were in good condition.

*A sidewalk in degraded condition along Colfax*

Sidewalk repair is needed along Colfax in the vicinity of the Study Area, but this is a minor issue overall.

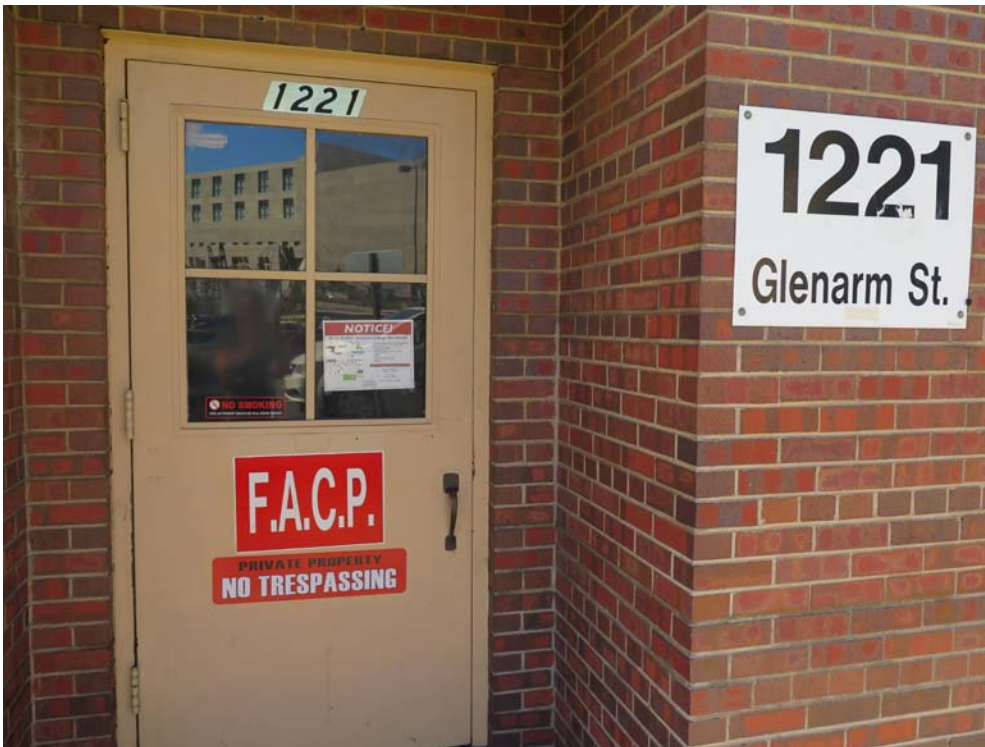
Additionally, relative to the rest of the Central Business District, the Study Area is substantially underutilized. The Area's most prominent and defining feature is the former campus of the Emily Griffith Technical College, which is a full city block that lies vacant. In the year since the closing of the campus, the old building has steadily gained boarded windows as broken ones are patched to prevent issues with vagrancy, but not replaced.

*All entrances to any school buildings in the Study Area are marked with notices of closure and signs forbidding trespassing*
