401 North Madison Landmark Designation Application

Denver City Council
December 12, 2022

401
North
Madison
Street

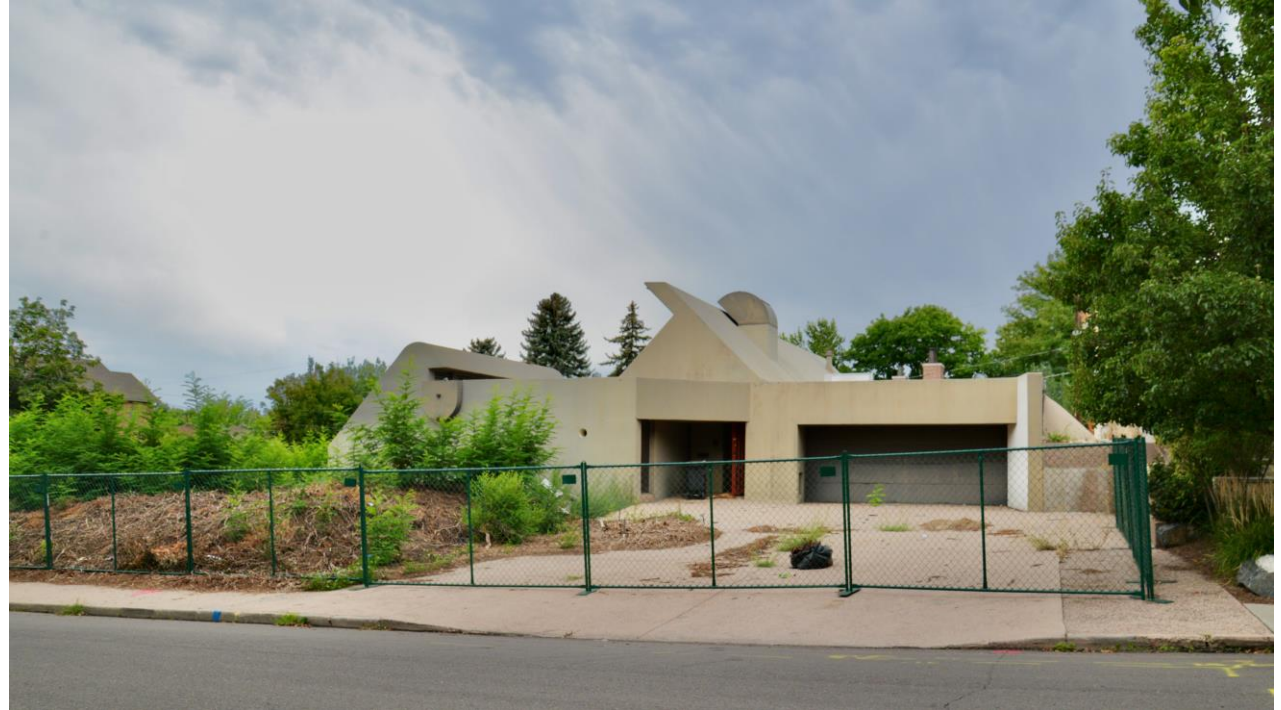
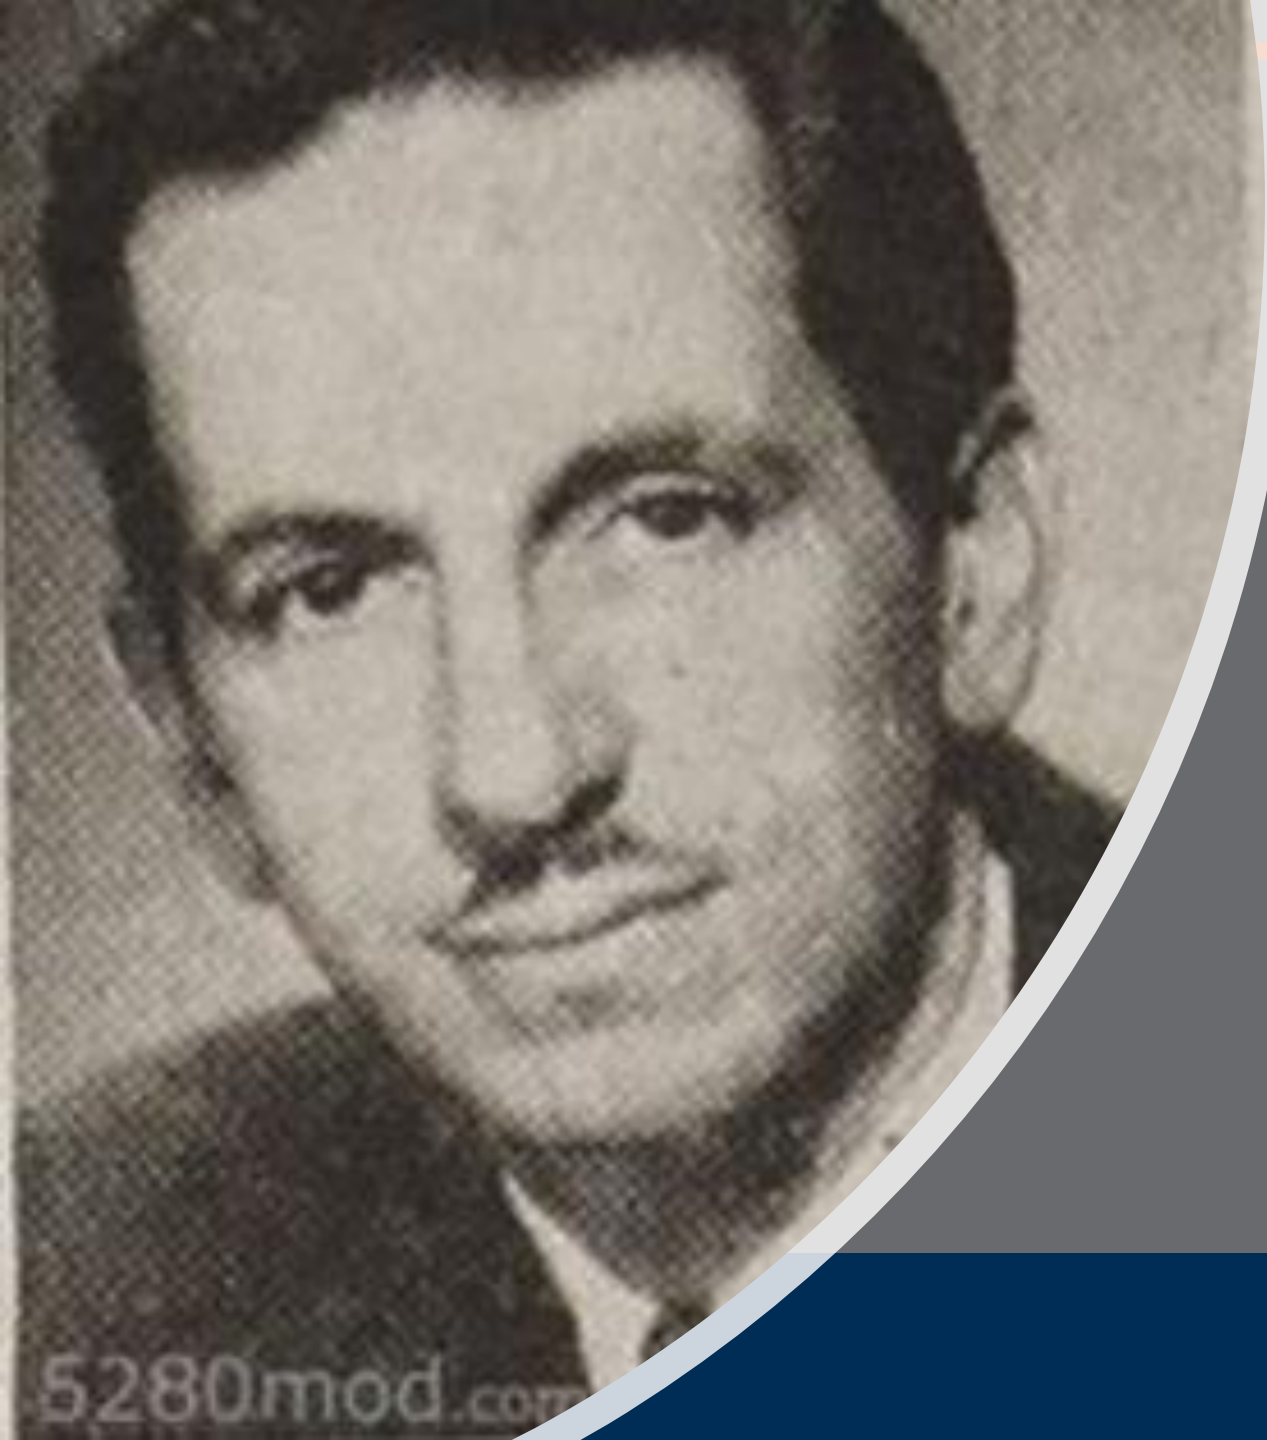
C. Embodies the distinctive visible characteristics of an architectural style

- Late Modern style
 - Horizontally oriented
 - Flat and shed roofs
 - Use of industrial materials like concrete
 - Hooded or deep-set windows
 - Large areas without windows
 - Eaveless
 - No ornament
 - Decorative use of functional features
 - Dramatic sculptural conception of building's volume

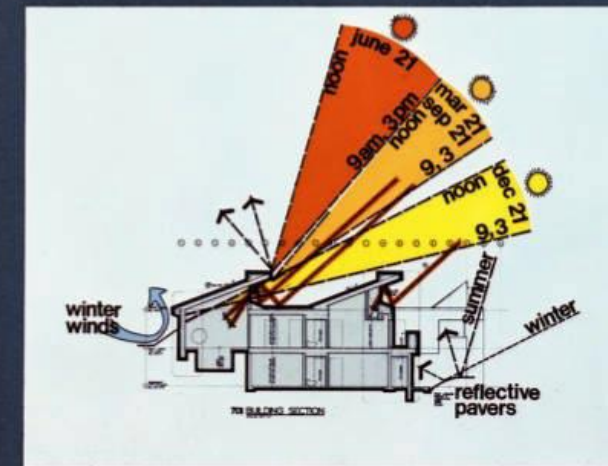
SOLAR ANGLES

- Horizontally oriented
 - Exception of large angled windows to capture sun light
- Solar-heated swimming pool and greenhouses
- Tinted concrete increases the solar gain
- Lighter stucco and concrete or metal materials redirect unwanted solar heat

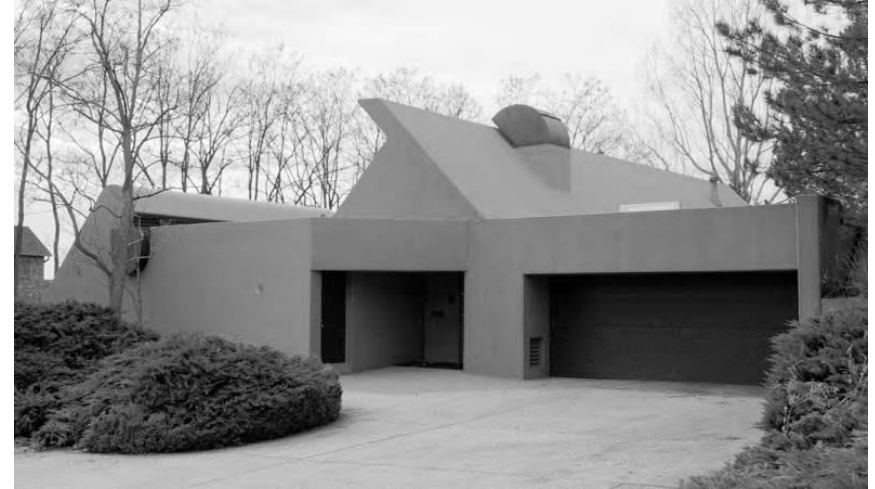
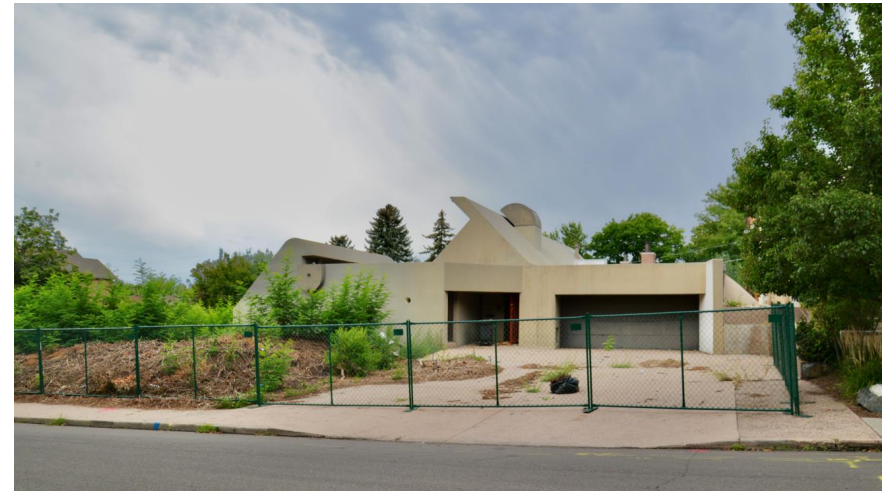
- High degree of integrity
 - Substantial basic structure of reinforced concrete exterior walls and interior floor tower
 - Recent vandalism
 - Energy conserving features of the design are intact
- Maintains aspects of integrity
 - Location, setting, feeling, and association
 - Energy conserving features of the design are intact
 - Design, materials, and workmanship
