# Structure Review Report

401 Madison Street  
Denver, CO 80206

Thursday  
October 27, 2022

Subject: Barton Consulting Services, LLC Project #22-124  
**Structural Report**  
401 Madison Street  
City & County of Denver, Colorado

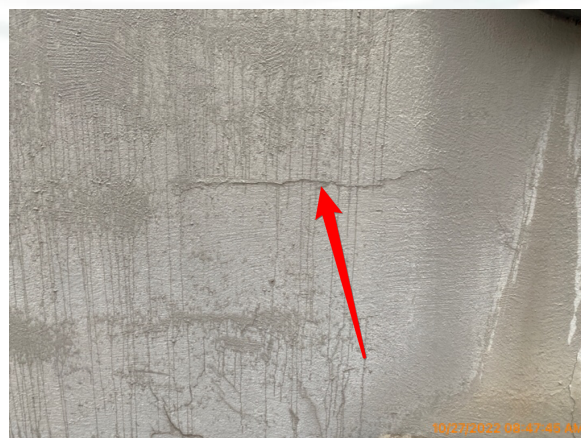
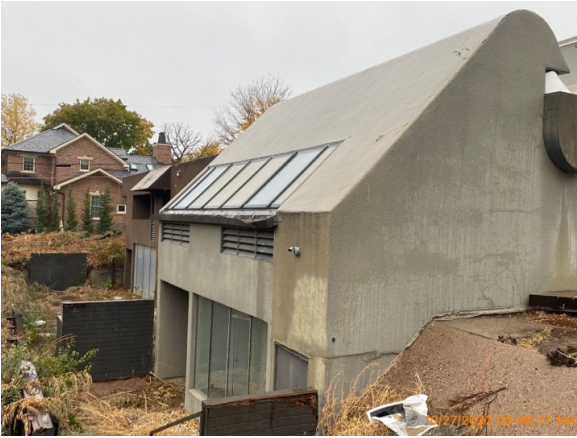
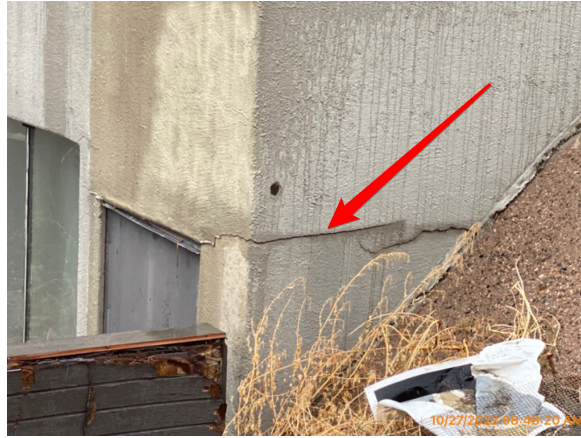
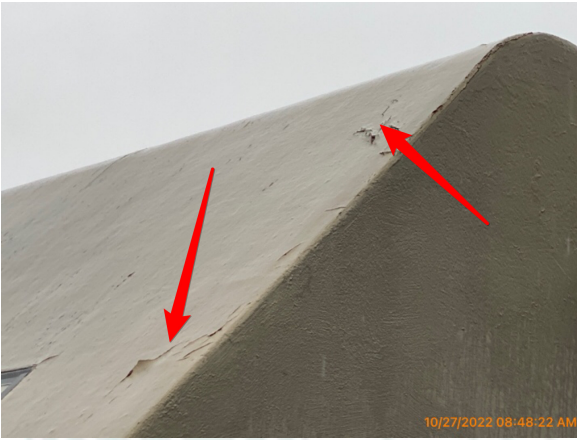
**DEF 6:** Siding condition was overall in poor condition. Top coat of EIFS stucco was visible deteriorated at multiple locations with damaged, cracks and signs of staining from moisture intrusion. This can allow for moisture intrusion.

Cracks visible in stucco

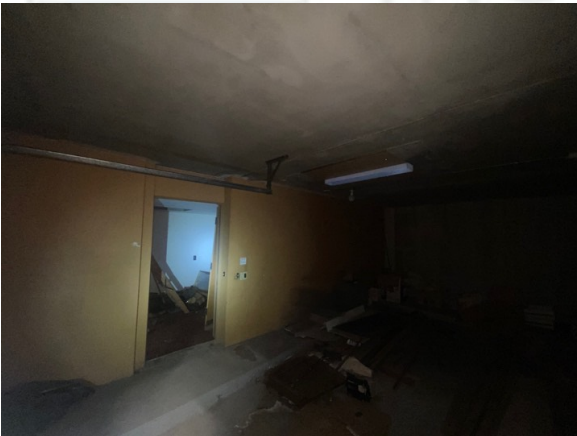
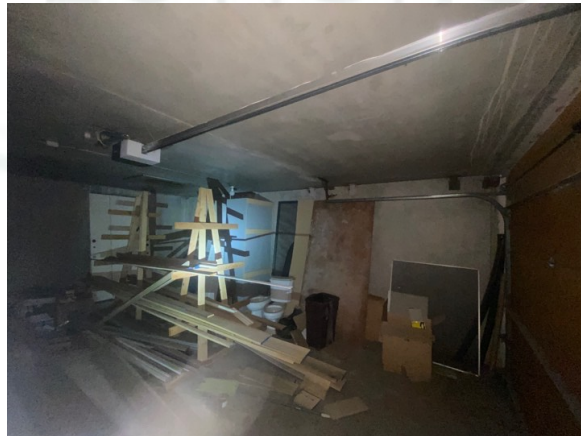
**MAR 7:** Garage consisted of concrete slab with concrete ceiling. Ceiling structure had cracks visible with signs of moisture intrusion.

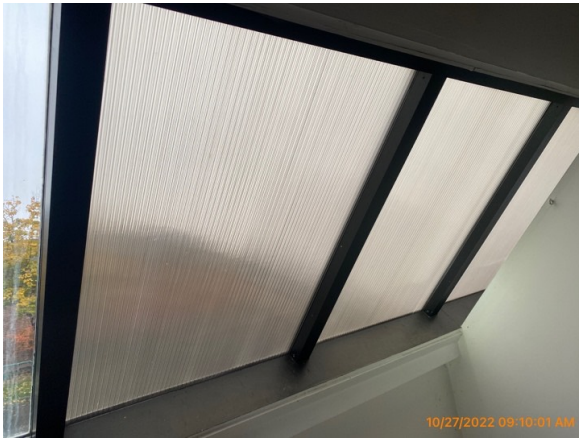
**MAR 8:** Windows were either metal framed double paned glass or plexiglass with two panes. Various windows appeared fogged, leaking, or damaged.

Plexiglass

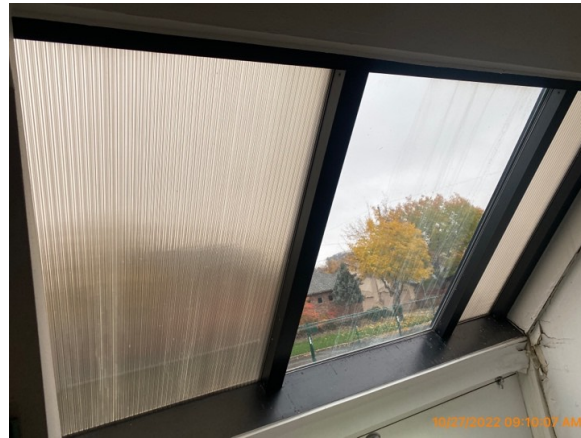
Fogged glass

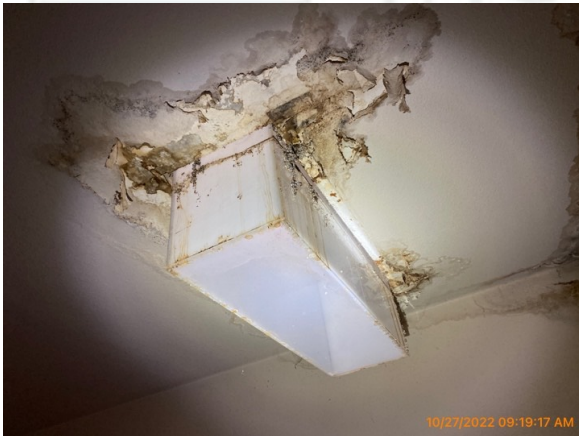
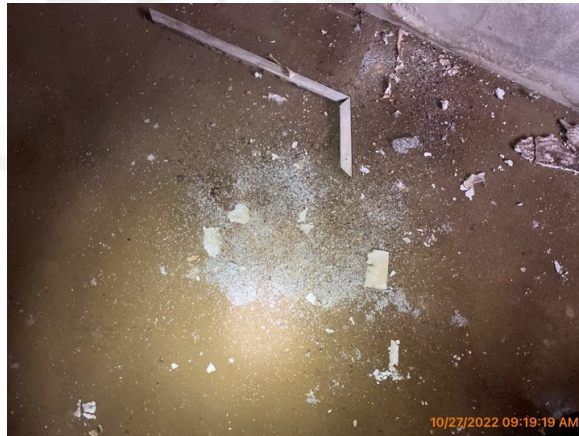
**DEF 9:** Signs of WDO intrusion (debris) at skylight in living room. Extent of intrusion could not be determined at the time of inspection.

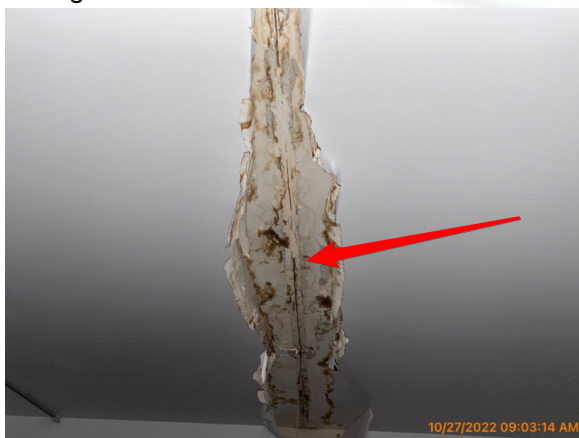
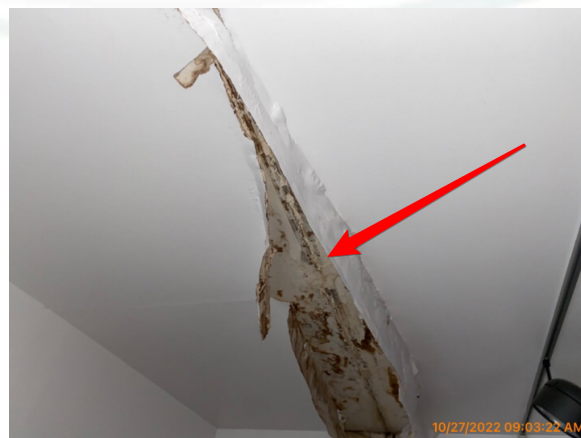
**DEF 16:** Structure was comprised of Concrete floor slabs, supporting walls and ceilings. Non-load bearing walls were comprised of wood 2x4 studs. Ceiling had damage at multiple concrete seams with microbial growth throughout home.

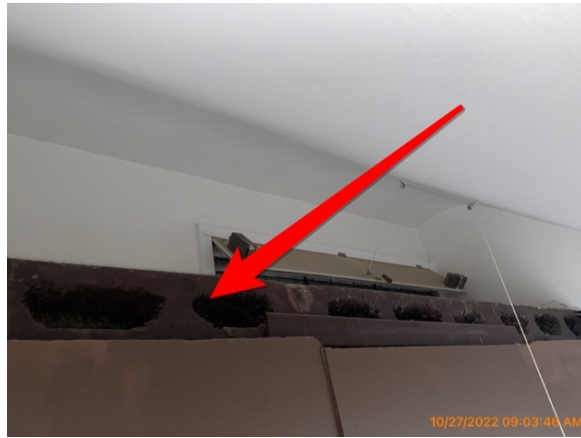
Concrete ceiling edge
