# 26th & Larimer Conditions Study

December 2021

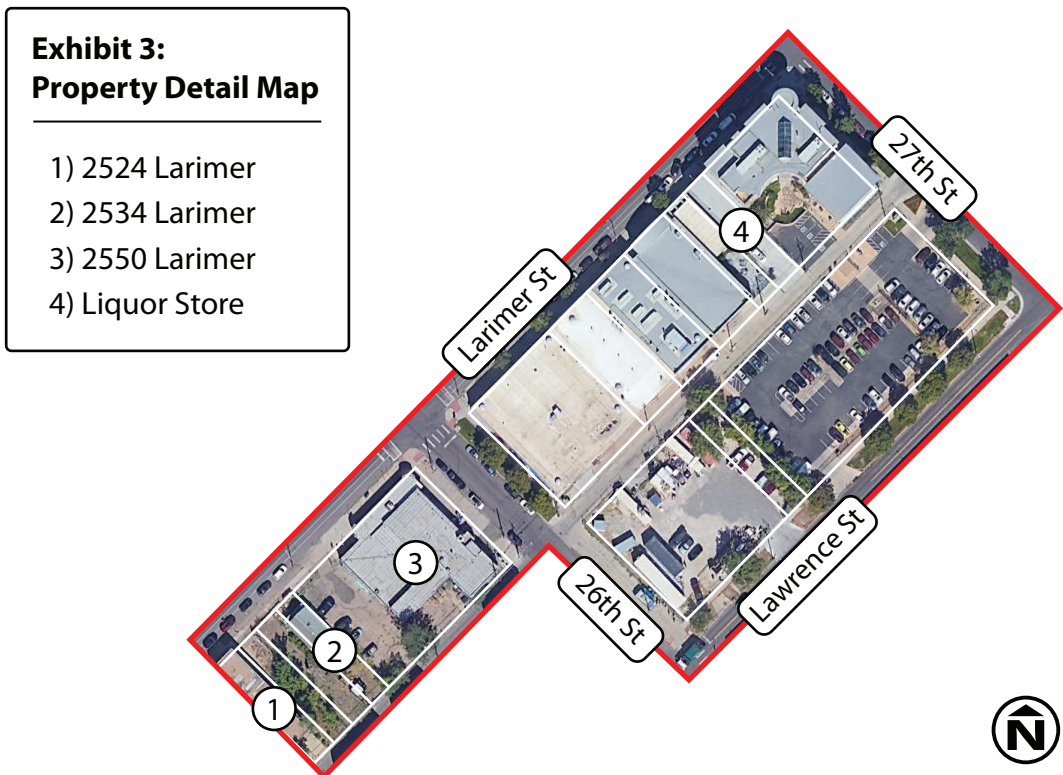
The following exhibit, **Exhibit 3: Property Detail Map**, shows the location of various properties within the Study Area discussed in this subsection.

At the southern end of the Study Area, 2524 Larimer St, (#1 in **Exhibit 3: Property Detail Map**), is a long-vacant warehouse property with deteriorating soffits and a mix of street art and some graffiti across its boarded front as well as its northeast side facing the adjacent vacant lot.

Farther northeast, on the other side of the vacant lot, is a residential property at 2534 Larimer Street (#2 in **Exhibit 3: Property Detail Map**). It dates to 1885, recently sold in 2021, and has long been used as a residential property. It was still occupied at the time of sale, but was boarded during the field survey. An examination of its physical condition revealed deteriorated exterior surfaces, uneven retaining walls, missing and damaged fascia boards with peeling paint, and a deteriorated roof. It was painted around 2016 with bright colors that suggest an eclectic, creative vibe.

Next at 2550 Larimer Street, (#3 in **Exhibit 3: Property Detail Map**), is a building commonly referred to as the “IMAC Building” due to the signage advertising its tenant, the IMAC Research and Development Center. This building has a street mural painted on its frontage along Larimer and 26th Streets. The mural portion of the building has no glaring maintenance issues, but there is a deteriorated loading dock in the back near the alley along 26th with some graffiti.

Across 26th along Larimer are several buildings owned and operated by the Volunteers of America. These structures, along with a liquor store, (#4 in **Exhibit 3: Property Detail Map**), form the entire half-block along the 2600 block of Larimer, and are in generally good condition and show ongoing maintenance. The liquor store building needs some tuck pointing and new signage, but is not significantly deteriorated.
