26th & Larimer Conditions Study

December 2021

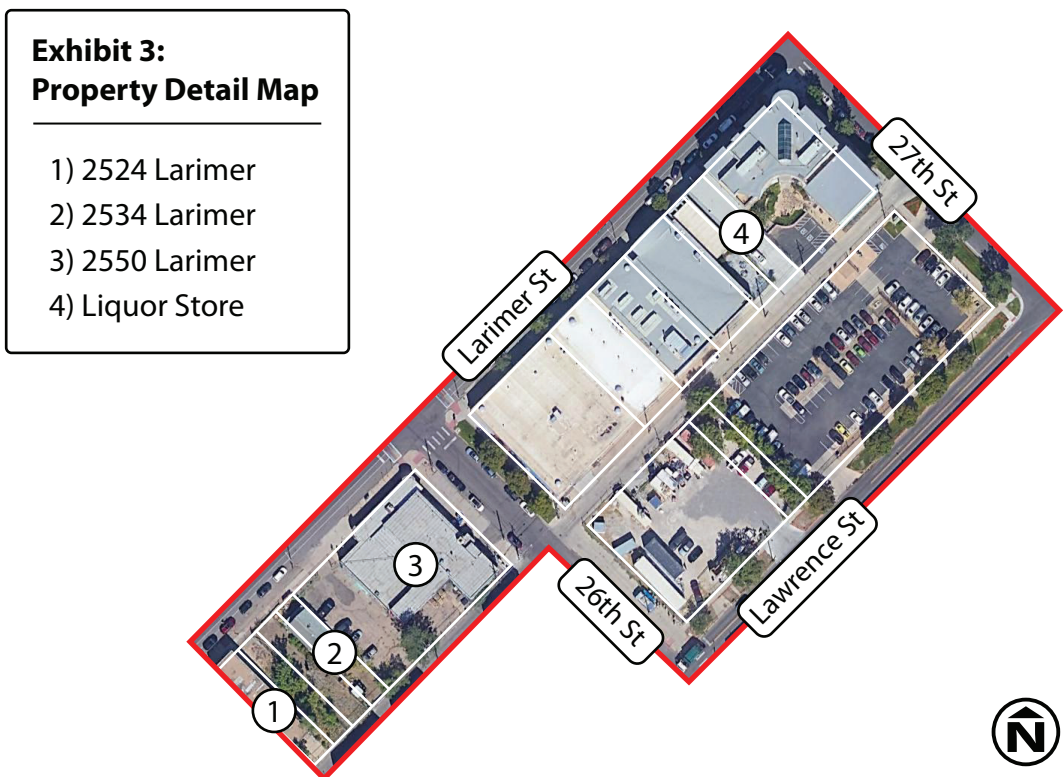
The following exhibit, **Exhibit 3: Property Detail Map**, shows the location of various properties within the Study Area discussed in this subsection.

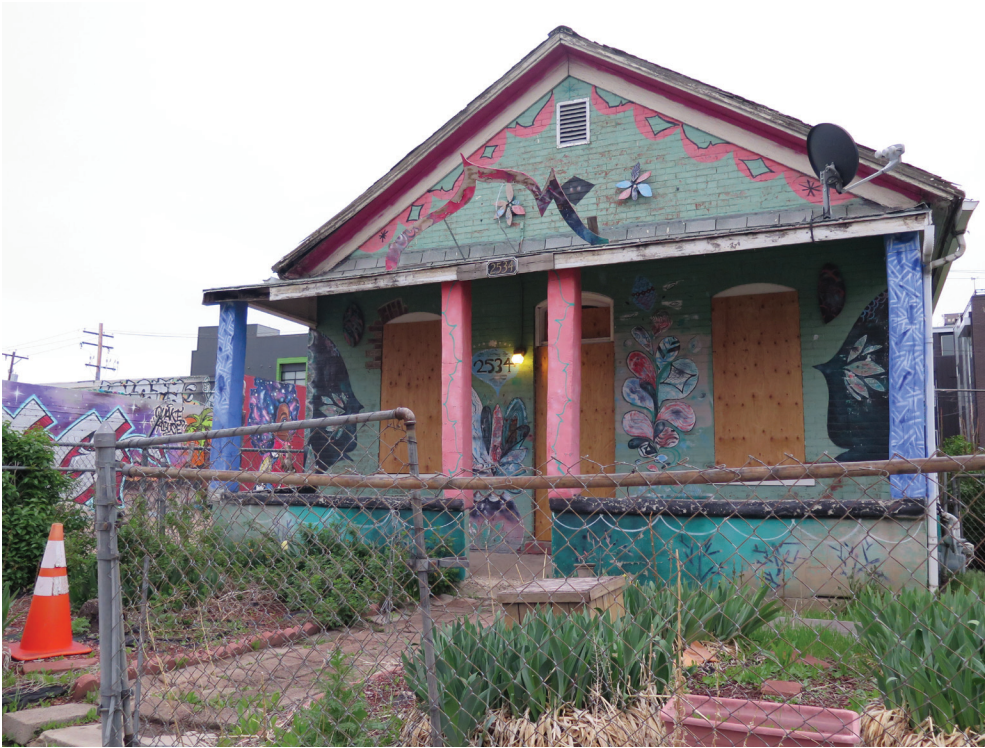
2534 Larimer St

Farther northeast, on the other side of the vacant lot, is a residential property at 2534 Larimer Street (#2 in **Exhibit 3: Property Detail Map**). It dates to 1885, recently sold in 2021, and has long been used as a residential property. It was still occupied at the time of sale, but was boarded during the field survey. An examination of its physical condition revealed deteriorated exterior surfaces, uneven retaining walls, missing and damaged fascia boards with peeling paint, and a deteriorated roof. It was painted around 2016 with bright colors that suggest an eclectic, creative vibe.

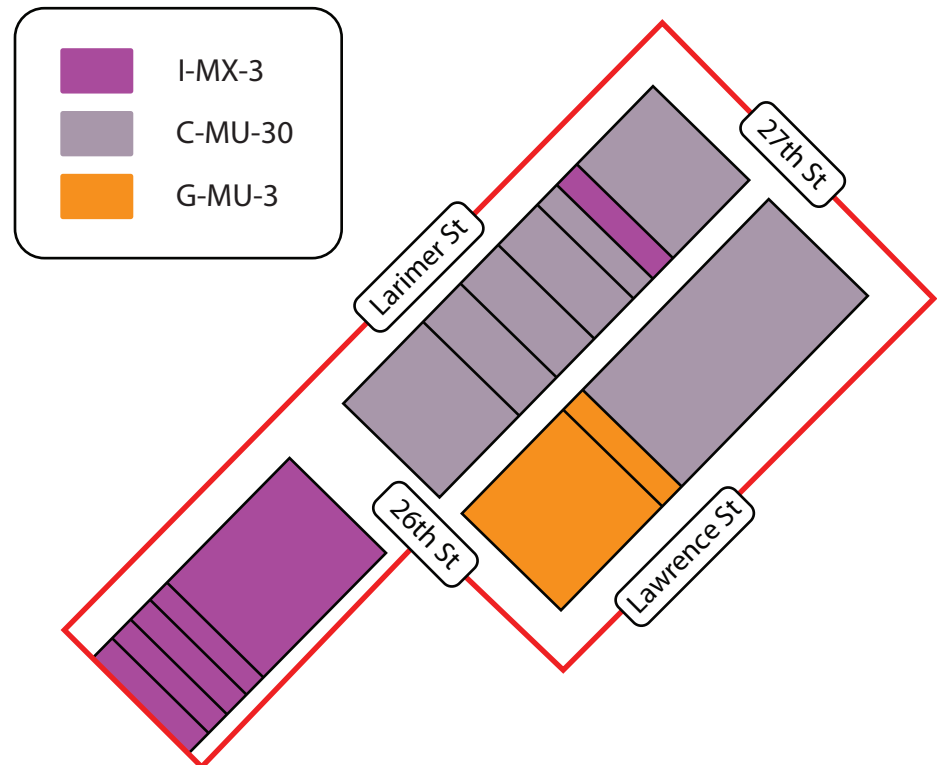
Each real property parcel in the Study Area has access to a public street as well as an alley, and each is of sufficient size to be developed under its current zoning designation. The layout of parcels in the Study Area and their zoning are shown below.

In the I-MX-3 district, there are no setbacks in many cases, and instead build-to requirements exist along public streets. These parcels, with one exception, are southwest of 26th Street and are now under the same ownership, giving flexibility with parcel assembly or subdivision.

The parcels zoned C-MU-30 are all owned by the Volunteers of America. This is a district that is established in the former "Chapter 59" zoning code that existed prior to the new code adopted in 2010. These lots are large enough to be developed under their code designations, are assembled under single ownership. They would likely be rezoned to conform to the new zoning code if redeveloped or renovated in a major way.
