# Emily Griffith Technical College Conditions Study

July 2017

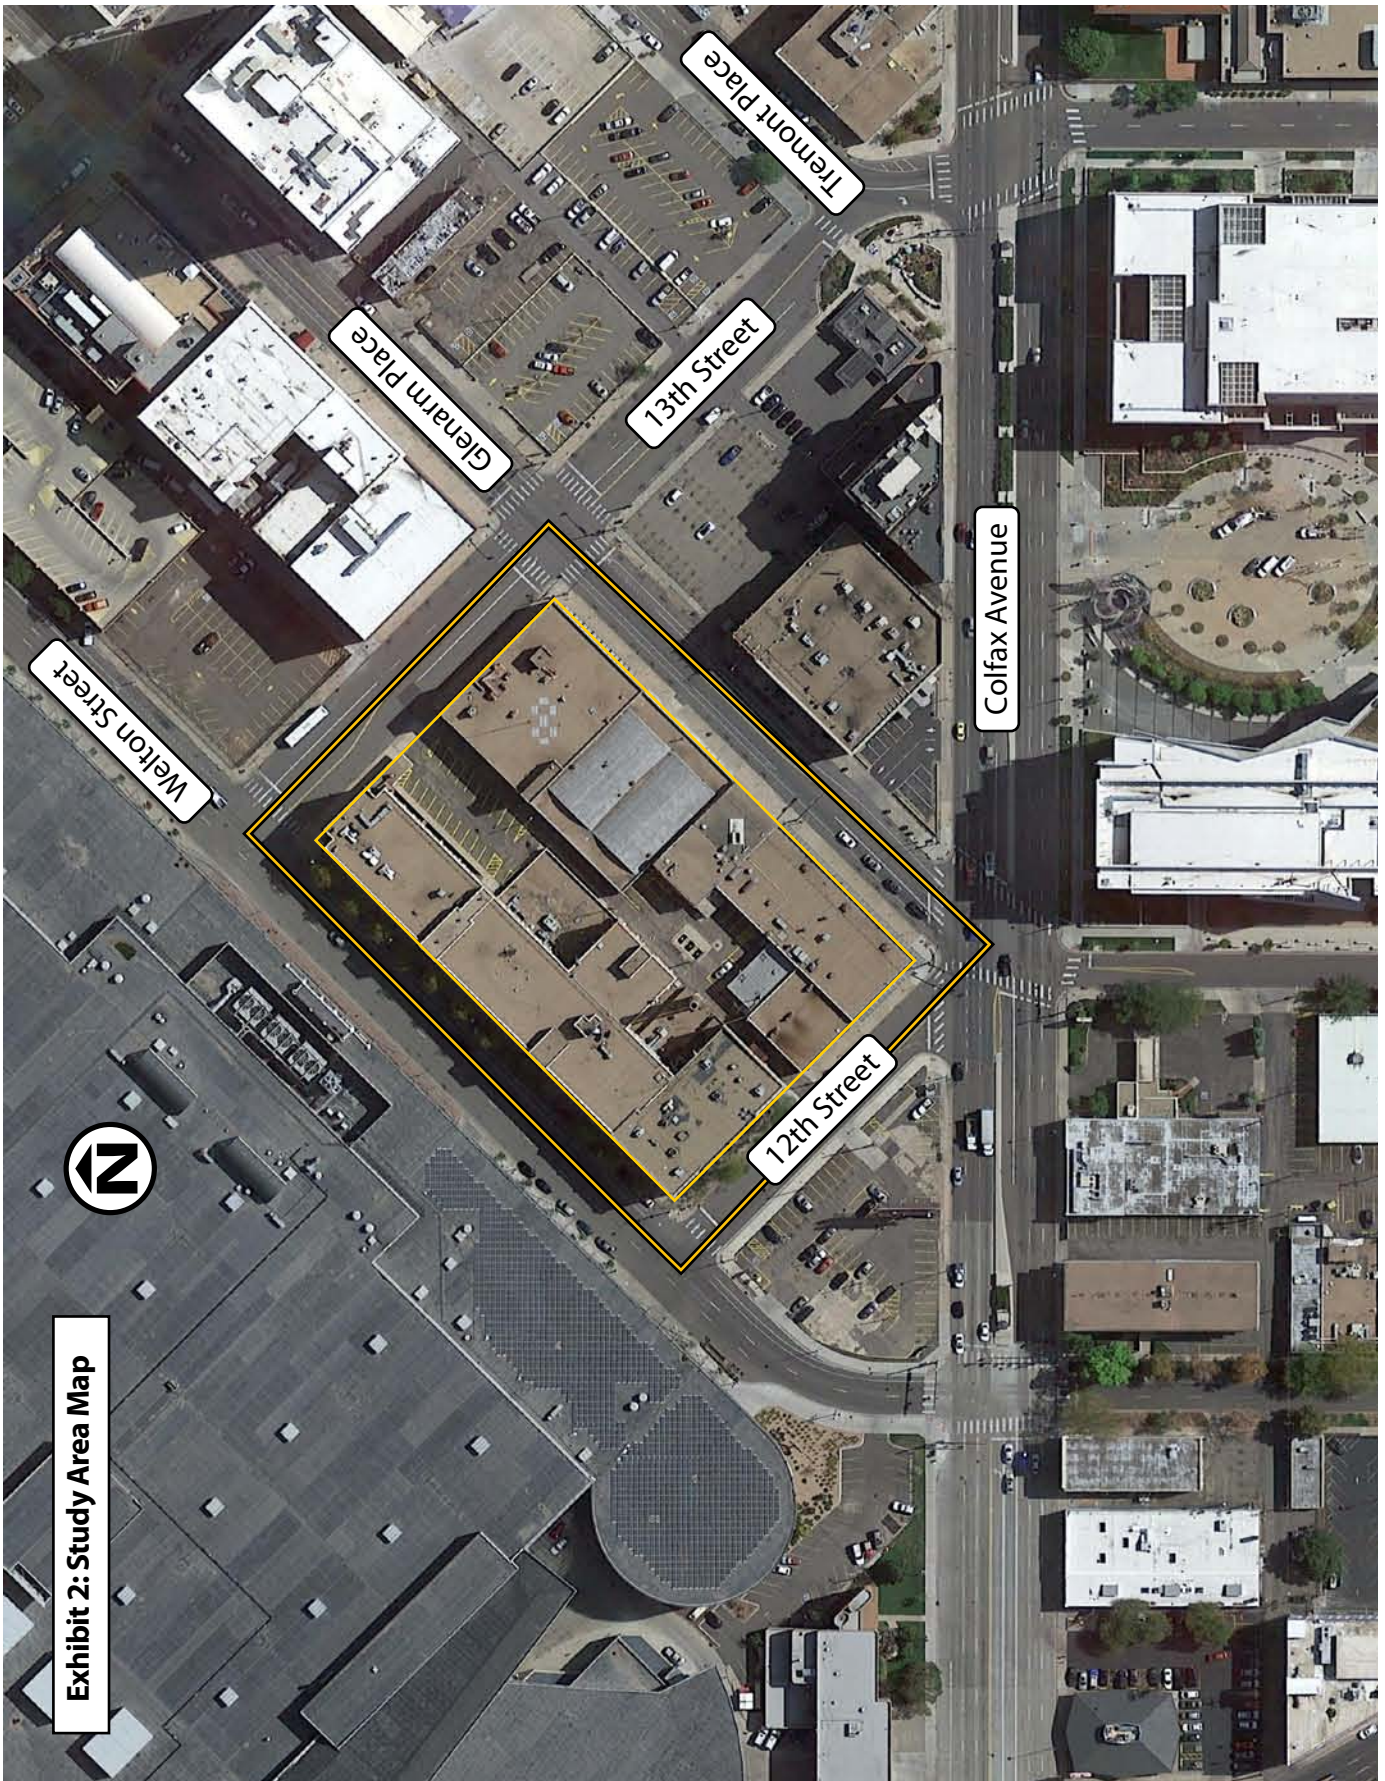
Exhibit 2: Study Area Map

**Exhibit 2: Study Area Map** visually depicts the physical boundaries of the Study Area.

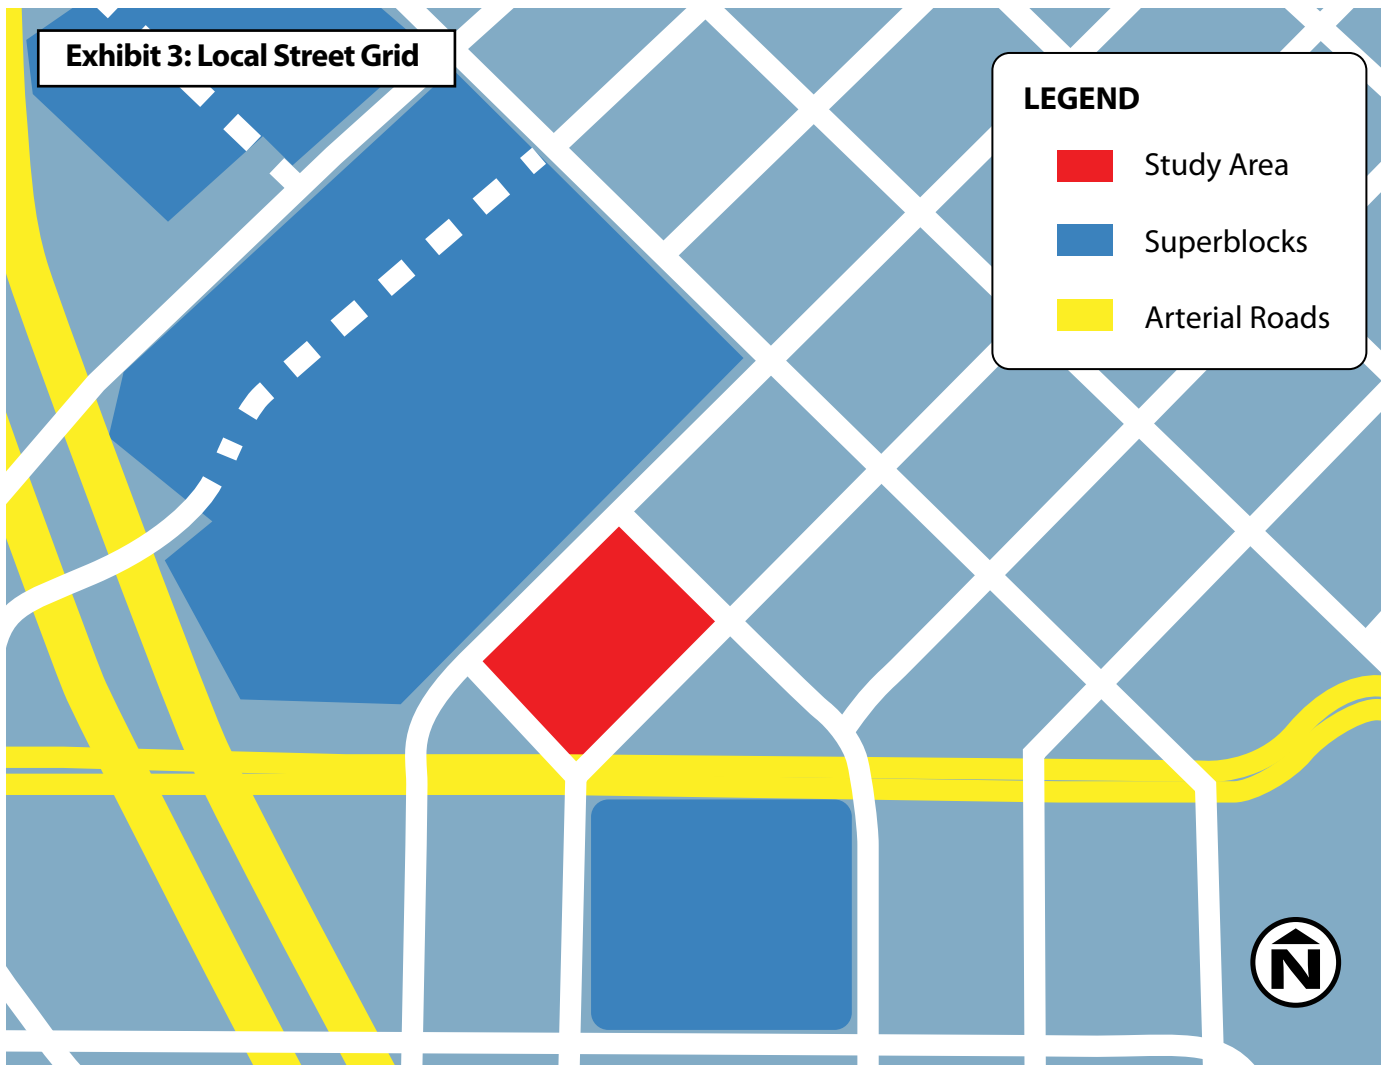
Even though they are streets that provide automobile access to the Study Area, Colfax Avenue and Speer Boulevard have an isolating effect with regard to pedestrian activity due to their constant flow of higher speed traffic which reduces access by modes other than automobile from the south and west, especially during peak traffic hours. Police data, discussed later in this section, shows that a significant portion of reported crimes in the vicinity of the Study Area are hit-and-runs along Colfax.

Overall, the Study Area encompasses an area of downtown that is somewhat isolated and removed from the surrounding area, both physically and psychologically—pedestrian activity and private investment in this section of downtown is far lower than the rest of the Central Business District to the northeast.

Although none of these issues are expected to be corrected by the urban renewal process, they do represent a challenge to the redevelopment of the Study Area.

Because of the lack of connections to the surrounding street grid and poor provisions for local traffic, a finding of *Inadequate Street Layout* **has** been made.
