# 2900 S. University Blvd.

Landmark Designation Application

# 2900 South University Boulevard

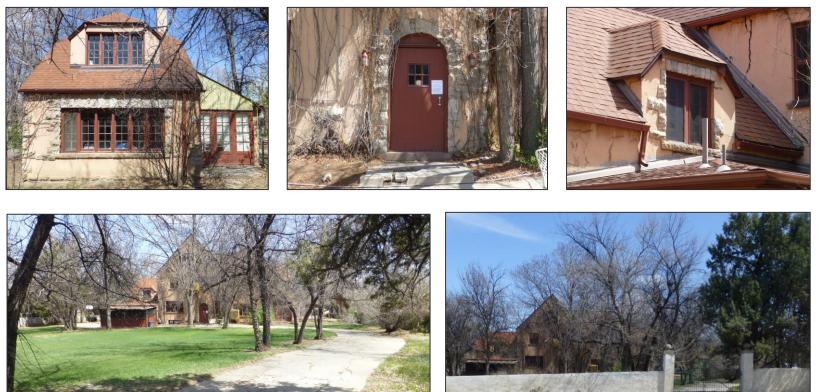
- French Eclectic Style
  - 1926 construction
  - Steeply pitched complex roof
  - Hipped dormers
  - Stuccoed walls
  - Stone as whimsical decoration
  - Multi-pane windows and French doors
  - Entry doorway arch and simple stoop without porch

- Rare and distinctive
- French Eclectic
- Rare style in Denver
- Rarer in post-war, ranch neighborhood
- Distinctive style and size for the area

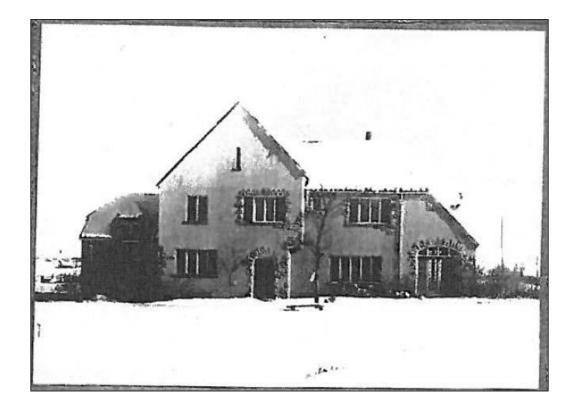
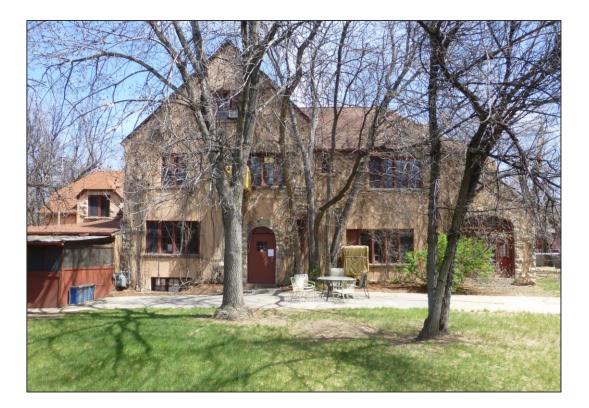
- Retains
  integrity
  - Location
  - Design
  - Workmanship
  - Materials
  - Setting
  - Feeling
  - Association

#### • Alterations

- Front porch
- Small side and rear additions
- Infilled garage
- Compatible size and material

Additions/Alterations Key:

a. Enclosure of original garage, c. 1930 b. Rear (East) one story addition, c. 1940 c. Rear porch enclosure, c. 1960 d. Addition on northwest corner of house, c. 1960 e. Wood shed addition, c. 1970
